Large Damage Bills (to buildings) From Cyclones Can Be Reduced By Small Actions

Tropical Cyclone Debbie

Damage to buildings in the Whitsunday Region

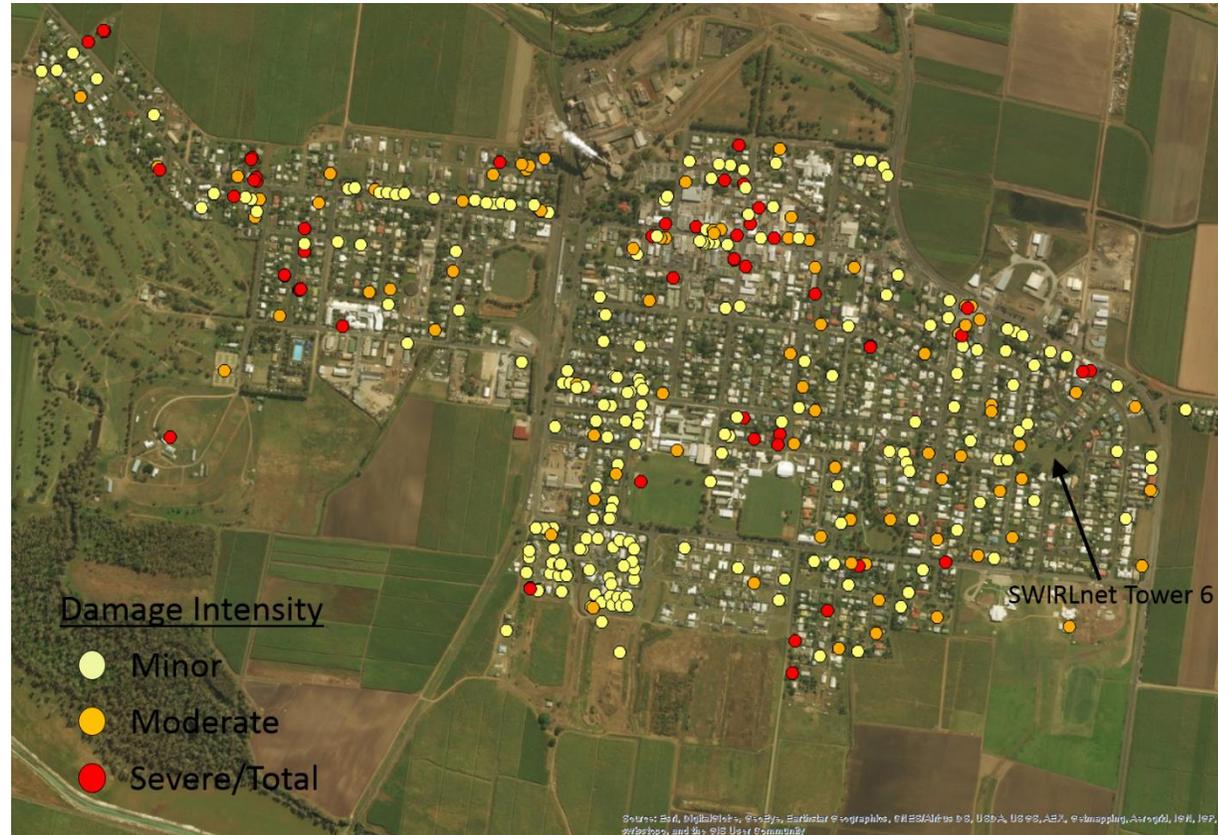
Majority of properties -
No observed
damage

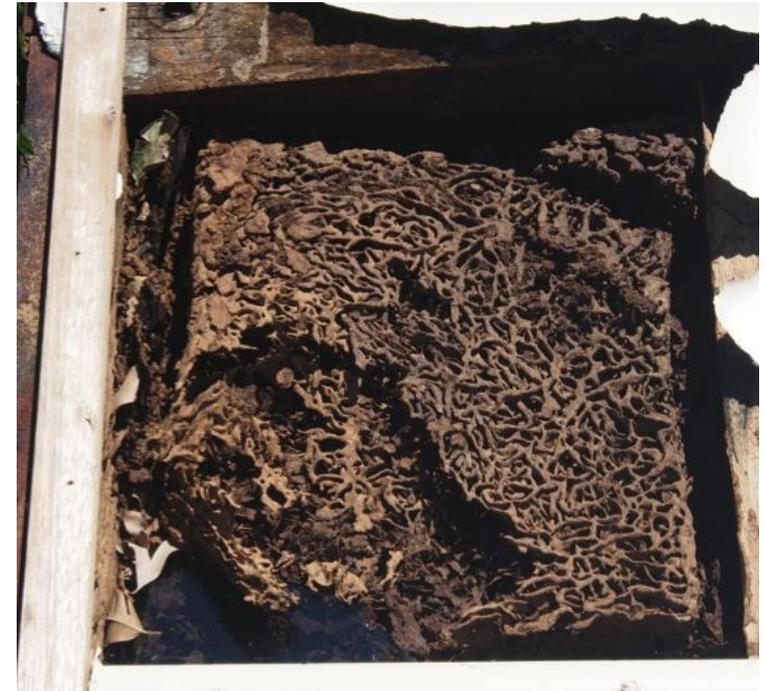
Rust, rot and termites

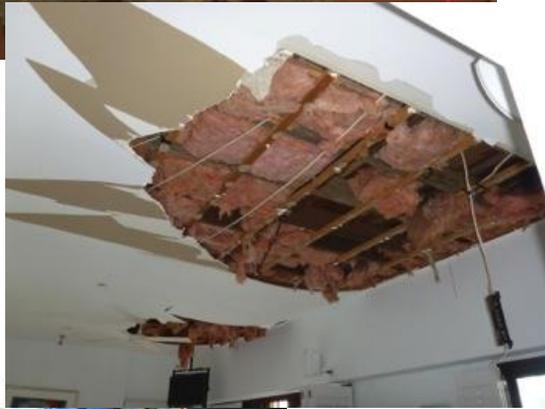
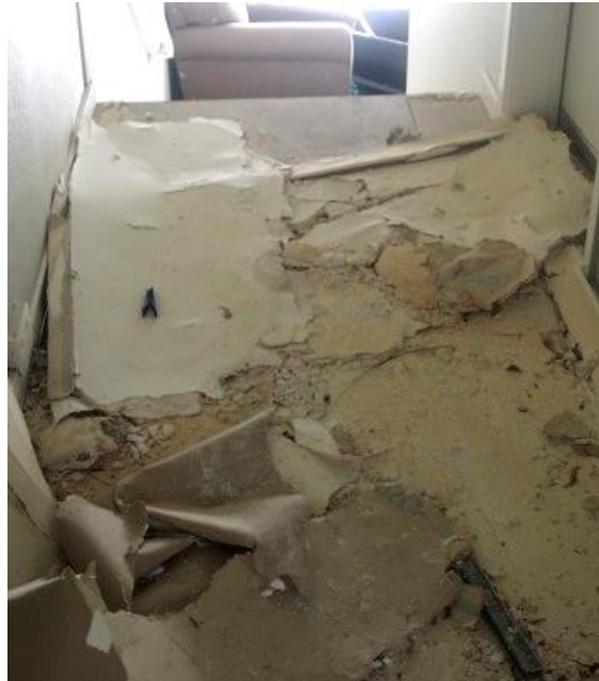
- Extensive damage to Plasterboard linings
- Corrosion of framing elements
- Non structural elements
- Mold and bacteria
- Odour

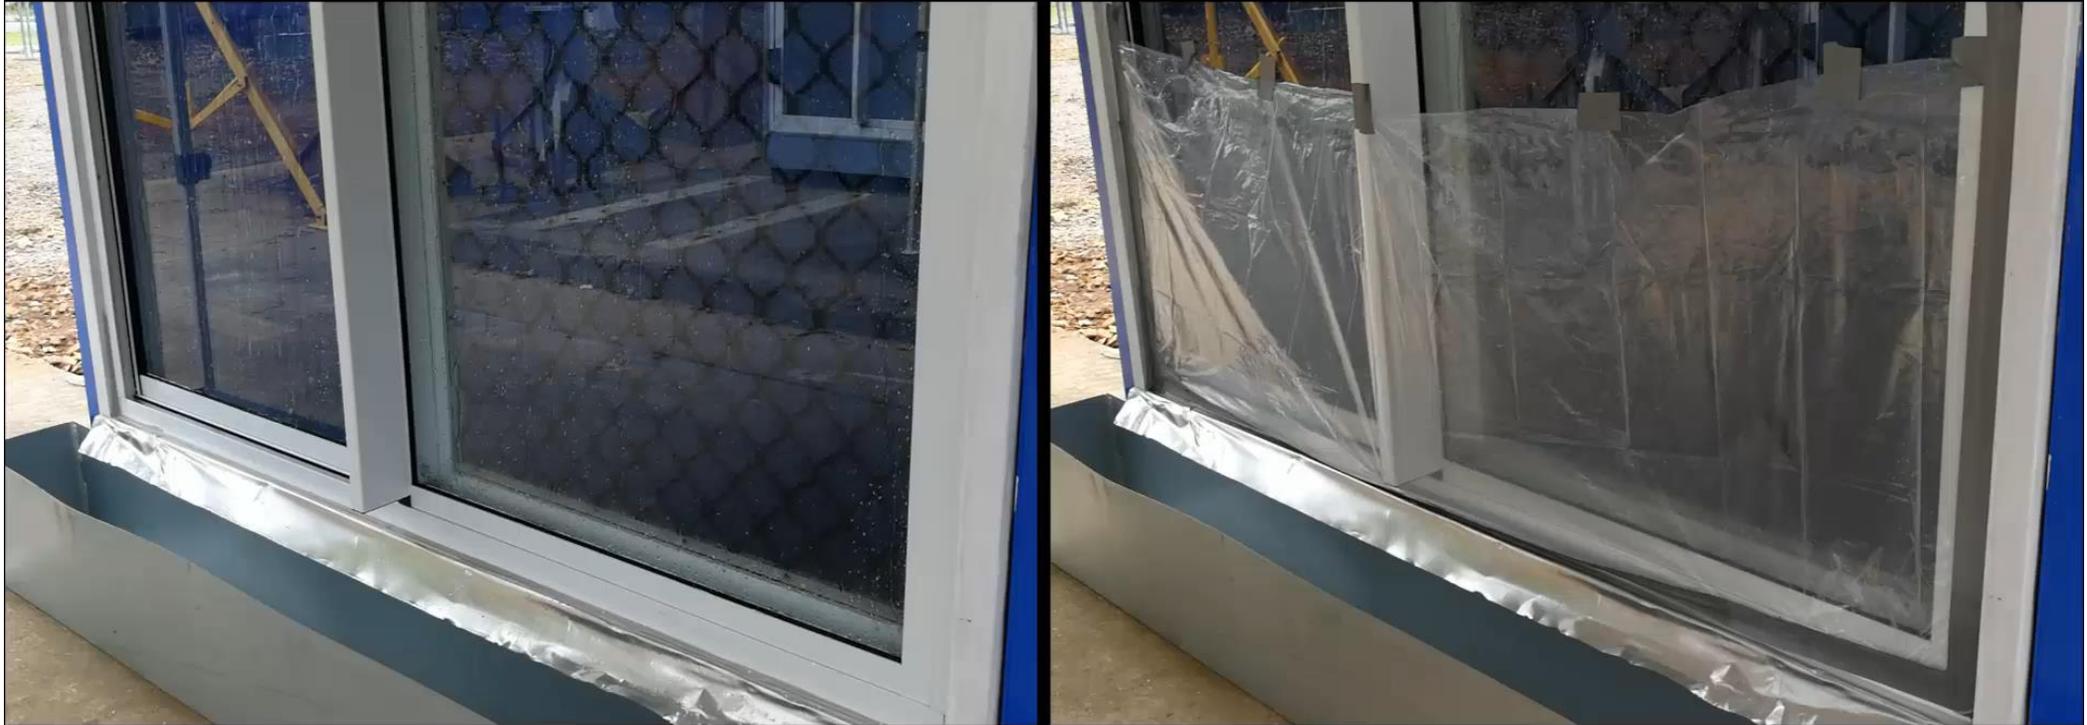
C2 Rated Sliding Door

1200Pa Max. gust applied over a 3min trace
