FAILURE MECHANISMS OF BRIDGE STRUCTURES UNDER NATURAL HAZARDS

Citation: Setunge, S. et. al. (2018) Failure mechanisms of bridge structures under natural hazards. Melbourne: Bushfire and Natural Hazards CRC.

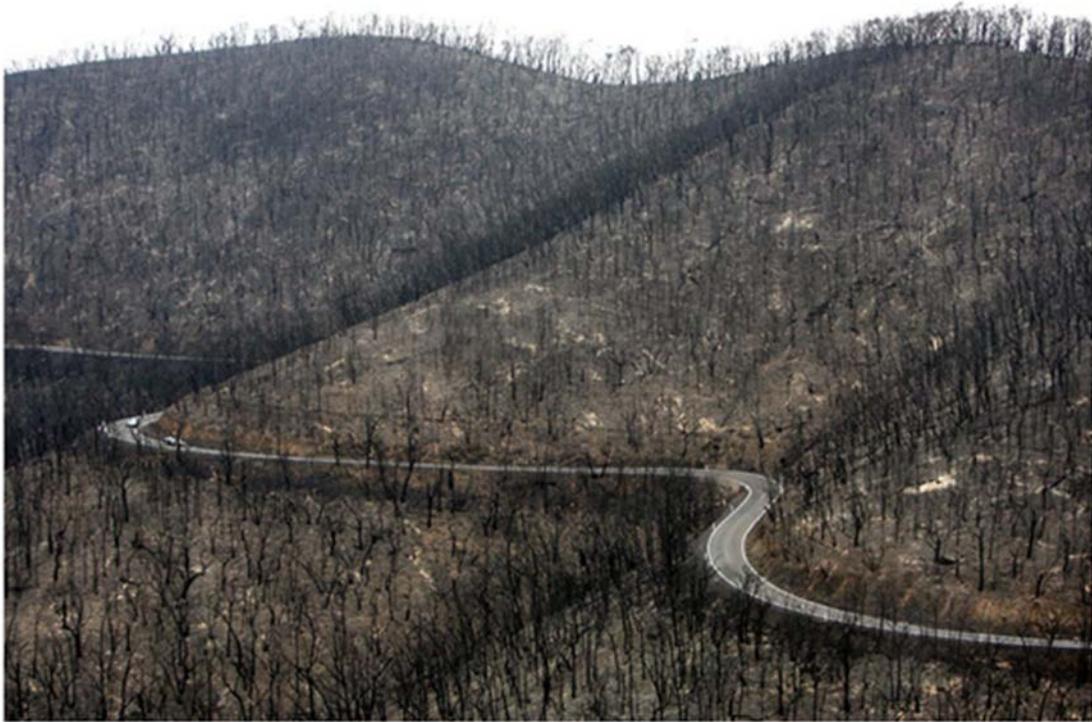
Figure 6 shows an after bushfire road infrastructure which illustrates the importance of the road network during and after a fire.

FIGURE 6: BUSHFIRE AREA - (GERAGHTY)

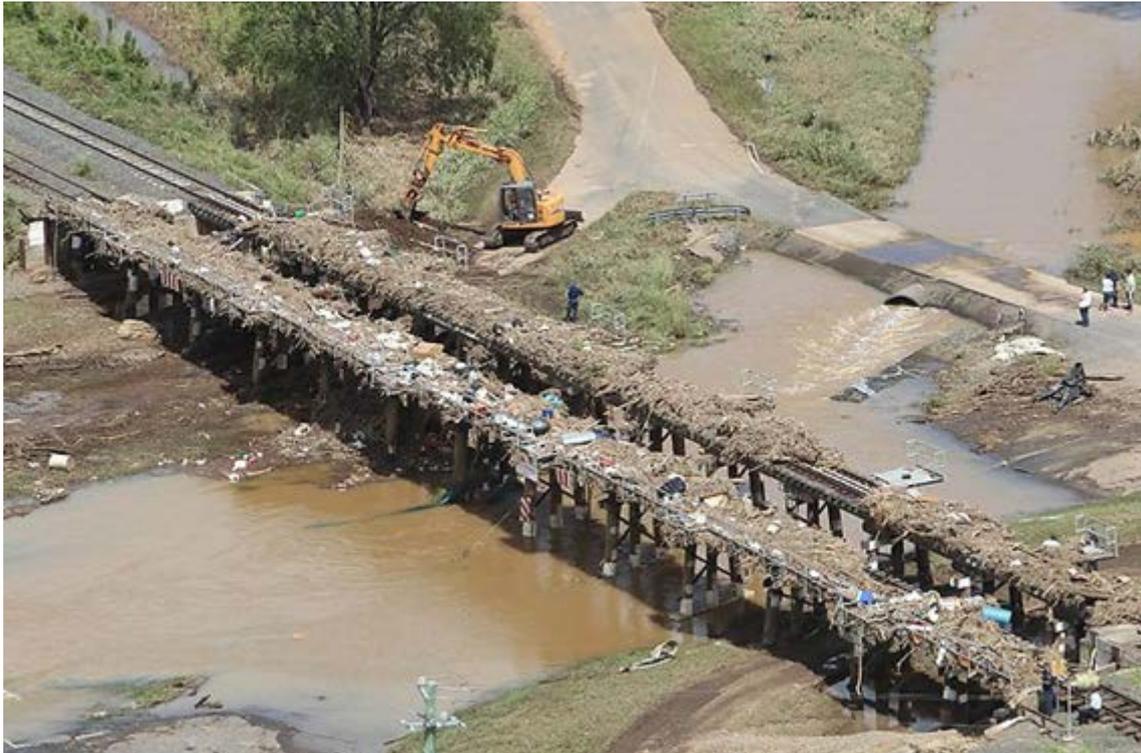
FIGURE 15: GRANTHAM FLOOD - COURTESY OF DAILY TELEGRAPH

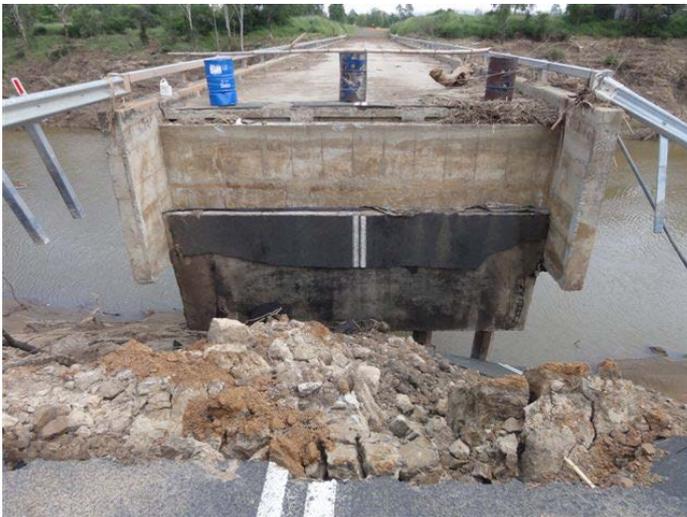
FIGURE 16: KAPERNICKS BRIDGE AFTER THE FLOOD ON JANUARY 2011 (BY LVRC)

Kapernicks Bridge is a three span, two lane precast concrete Girder bridge located on Flagstone Creek Road. The superstructure comprised of prestressed concrete I girders with a reinforced concrete composite slab. Kapernicks Bridge has two piers on each side of upstream and downstream. Tragically, bridge was failed due to the debris impacts arisen from the flood during January 2011. The failure of bridge occurred due to an accumulation of neglected structural shortcomings and the scour under the piers. Even though, the bridge had severe damages by the flood, it had now been repaired and is now in service. Prediction of the bridge pier scour depth of Kapernicks Bridge is made in terms of upstream and downstream sides[75].

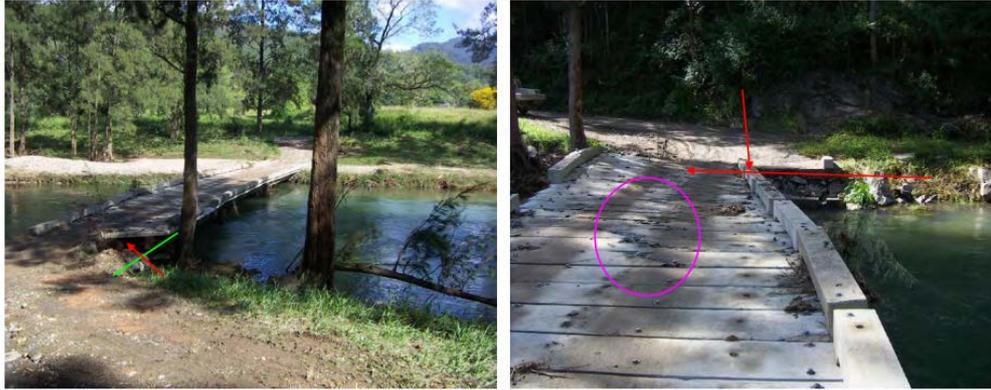
FIGURE 20: LATERAL DISPLACEMENT DUE TO FLOOD [78]

Forces from the flood water flow, debris and log impact increase the possibility of lateral movement of bridges. Hydrostatic force of flood water also helps uplifting the bridge deck and facilitates the occurrence of lateral displacement. This failure mode can be simulated by considering a combination of the flood loading calculated to be applied on the structure.

Lateral displacement of the bridge towards downstream side

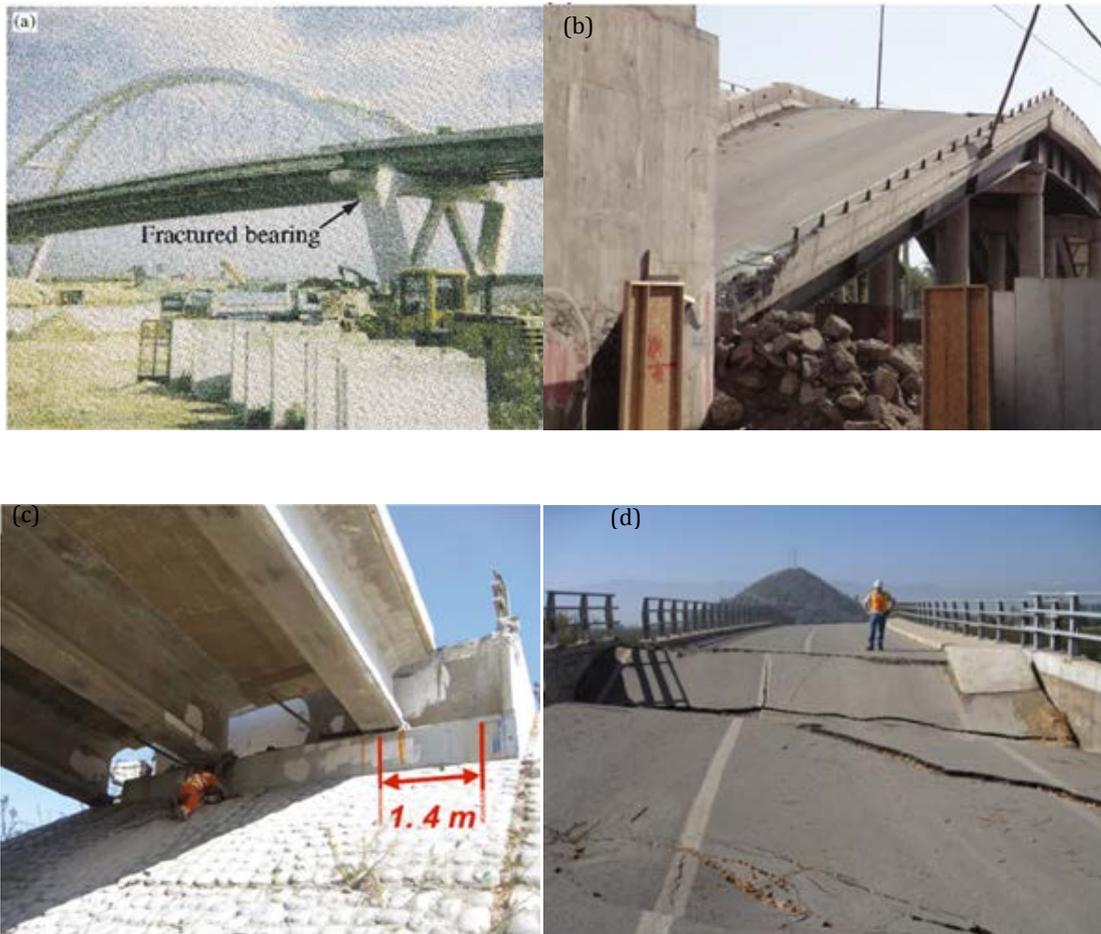
FIGURE 21: (A) FRACTURE OF BRIDGE BEARING OF NIELSEN BRIDGE TYPE DUE TO HANSHIN-AWAJI EARTHQUAKE
 (B) LOSS OF SUPPORT AT ABUTMENT OF THE MANUEL ANTONIO MATTA BRIDGE DUE TO CHILE EARTHQUAKE
 (C) LATERAL MOVEMENT OF ABUTMENTS DUE TO CHILE EARTHQUAKE
 (D) SETTLEMENT OF BRIDGE APPROACH SLAB DUE TO CHILE EARTHQUAKE

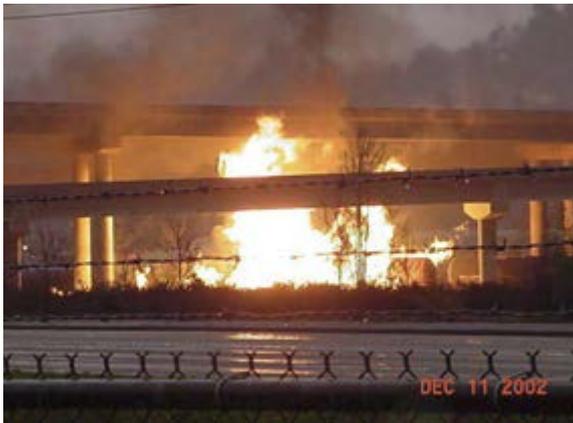
FIGURE 22: FIRE - STEEL BRIDGE[101]

Fire disaster impact on road infrastructure could be a result of bushfires or accidents on the roads or on their adjacent environment. The impact of the elevated temperature caused by fire on material types used in construction of bridges, culverts and flood-ways could lead to degradation of structural or functional capacity of the structures and eventually failure of their elements.

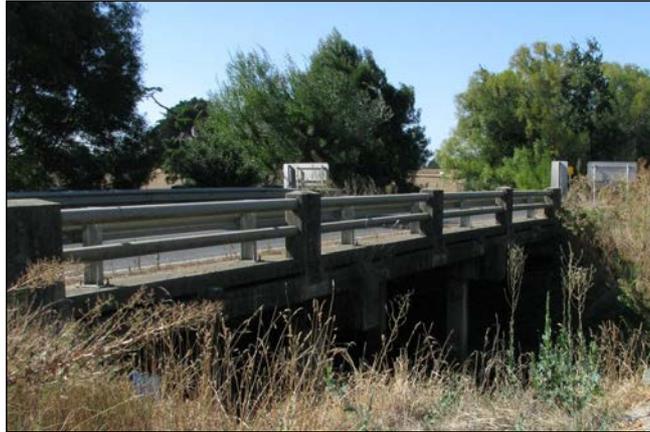
FIGURE 32: CASE STUDY BRIDGE

While an extensive amount of bridges are in use in Victoria, an older structure will be used in this cases study assessment with the age ranging from 50 – 59 years. Both reinforced flat slab bridges and reinforced decking unit bridges common through the region will be assessed. Based on the standards of the time an assumed cover depth of 30mm in beams/slabs and 40mm in columns will be used.

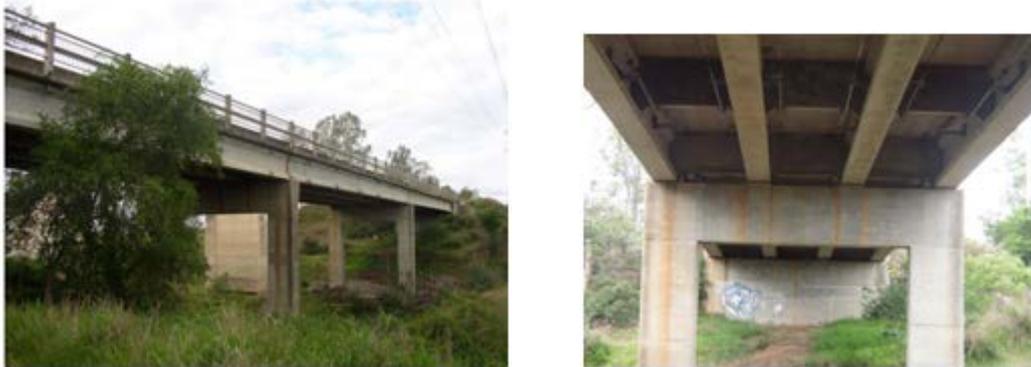
FIGURE 1: SECTION DETAIL OF THE TENTHILL CREEK BRIDGE (SETUNGE ET AL., 2002)

Gatton, Queensland. The bridge is 82.15m long and about 8.6m wide. It is supported by a total of 12 pre-stressed 27.38m long beams over three spans of 27.38m. Both ends are supported by two abutments and two headstocks as shown in Figure 1.
