CTS Preliminary Damage Assessment Report  
Tropical Cyclone Marcia, Queensland Australia  
February 20<sup>th</sup>, 2015

Corresponding Author:  
Daniel J. Smith, Ph.D.,  
[daniel.smith8@jcu.edu.au](mailto:daniel.smith8@jcu.edu.au)

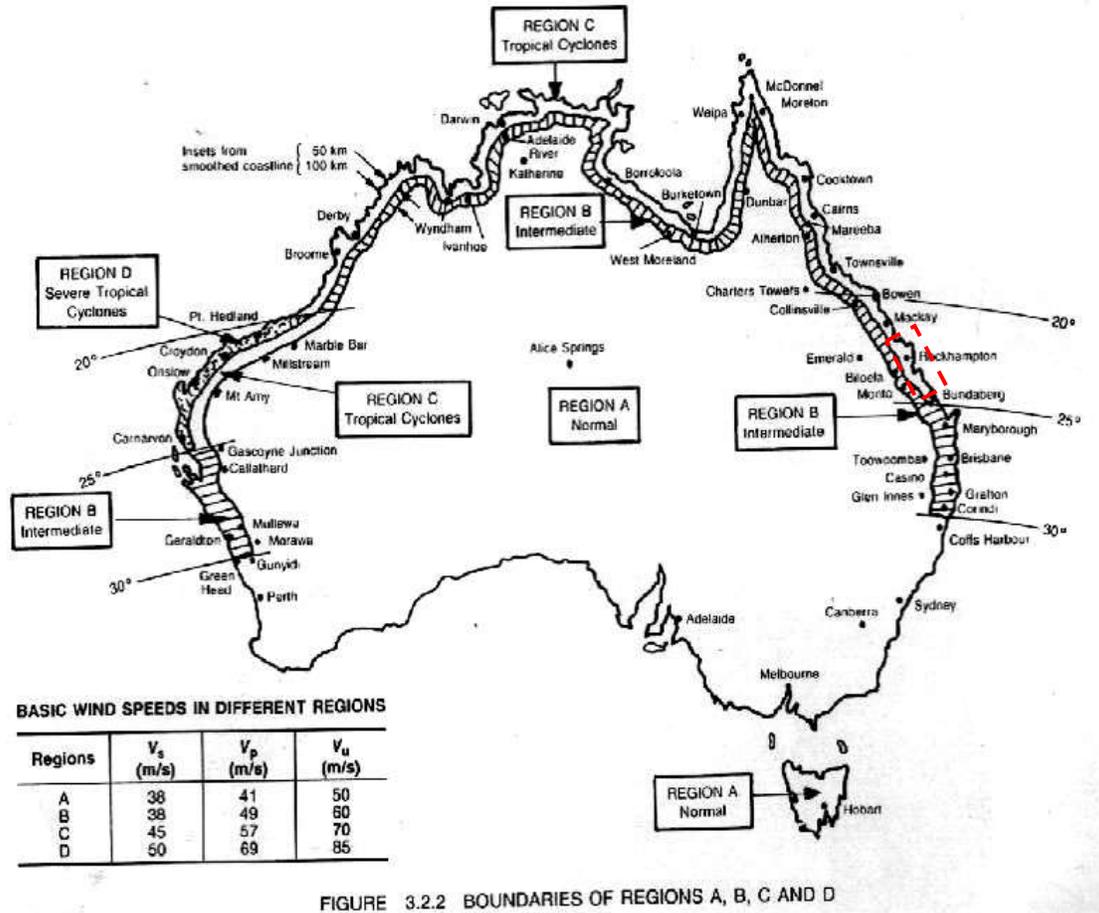
FIGURE 3.2.2 BOUNDARIES OF REGIONS A, B, C AND D

**Figure 2.** Design wind speeds for Australia based upon AS 1170.2 (1989). The region impacted by Tropical Cyclone Marcia (highlighted by the red rectangle) has a design wind speed of 70 m/s (250 km/h, V0.2).

The design wind speeds for Australia are defined in AS 1170.2 as shown in Figure 2. Residential structures designed in Queensland since the mid-1980s likely meet these design criteria. The coastal regions impacted by Tropical Cyclone Marcia have an ultimate design wind speed of 250 km/h (V0.2), well above the wind speeds recorded by the local weather stations (V600, V3).

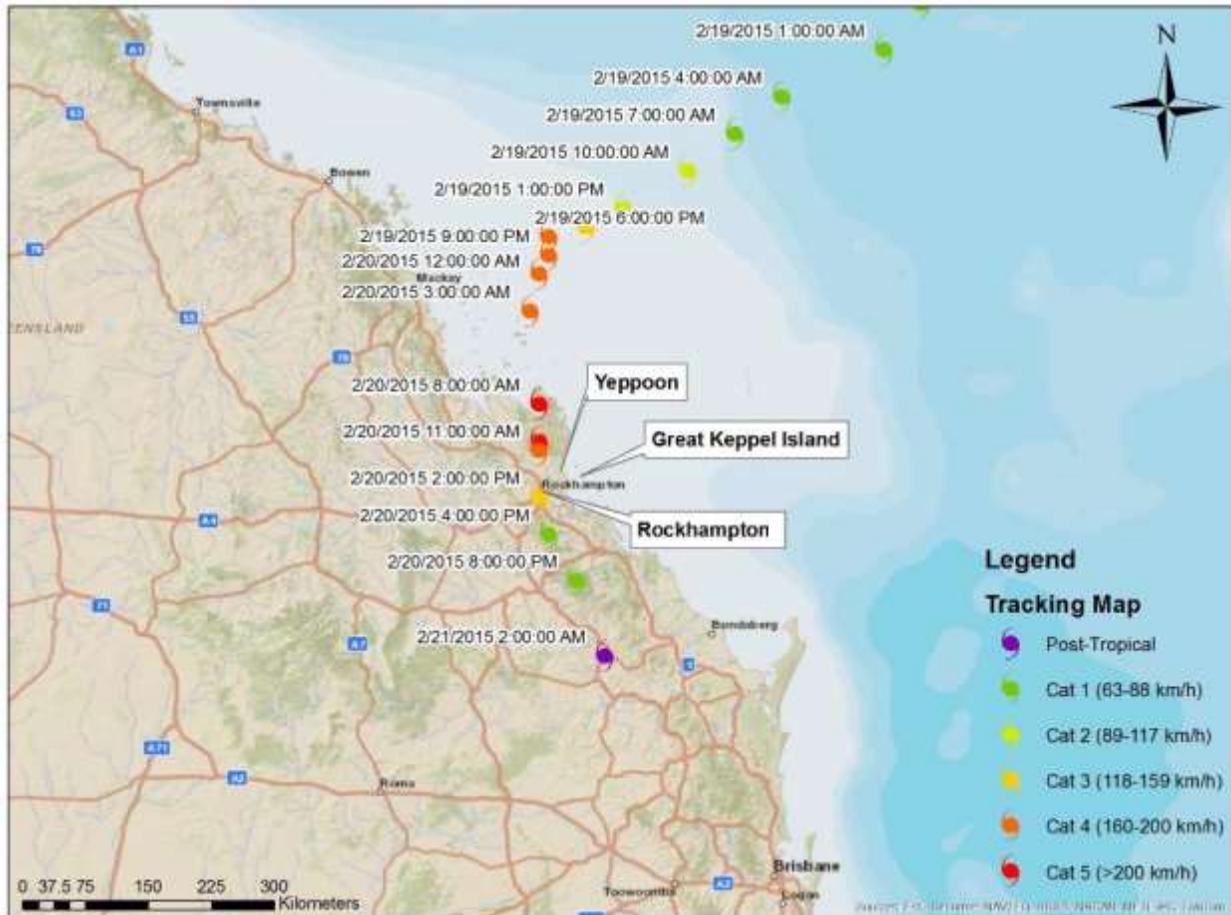
**Figure 3.** Tracking map for Tropical Cyclone Marcia based upon bulletins from the Australian Bureau of Meteorology. Times are in Australian Standard Time (+10 UTC). Cyclone categories refer to 10-minute sustained (V600) wind speeds.

Figure 3 shows the track of Marcia based upon bulletins from the Australian Bureau of Meteorology (BOM). Times are given in Australian Eastern Standard Time (AEST), which is 10 hours ahead of UTC. It should be noted that the Category designations are from the BOM, and differ from the Saffir-Simpson Scale used in the United States. The scales are summarized in Table 1. Note that the Australian classification uses 10-minute sustained (mean) as opposed to the 1-minute sustained (mean) used by the Saffir-Simpson. Therefore the 3-second peak gust speeds (used by both scales) should be used for comparison purposes.

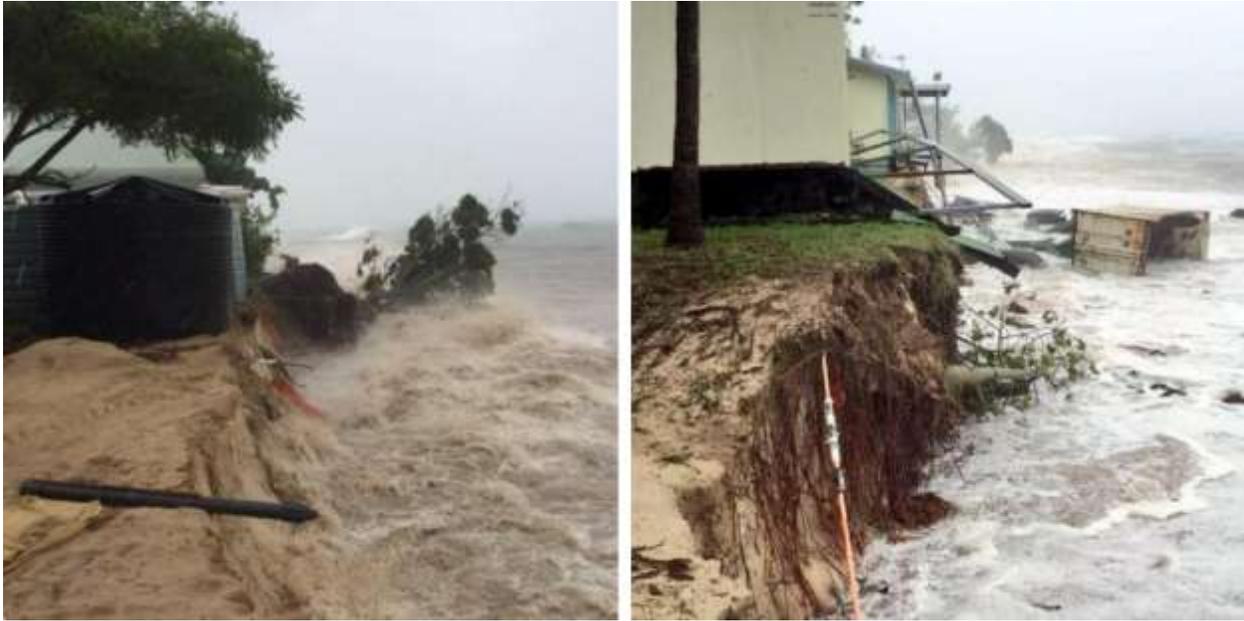
**Figure 4.** Severe structural damage along the coast of Great Keppel Island due to the storm surge of Tropical Cyclone Marcia. Photos courtesy of [9News Brisbane](#).

Great Keppel Island is located approximately 15 km from the town of Yeppoon off the Australian mainland. The island covers 14.5 km<sup>2</sup> and is sparsely populated, with the majority of the structures consisting of resorts and villas on the west side of the island. The island is known for its multiple beaches and hard coral reefs. Much of the damage to the island appears to have been caused by the storm tide, with reports and photos showing at least three properties with severe structural foundation failures due to rapid erosion. Figures 4 and 5 are examples.

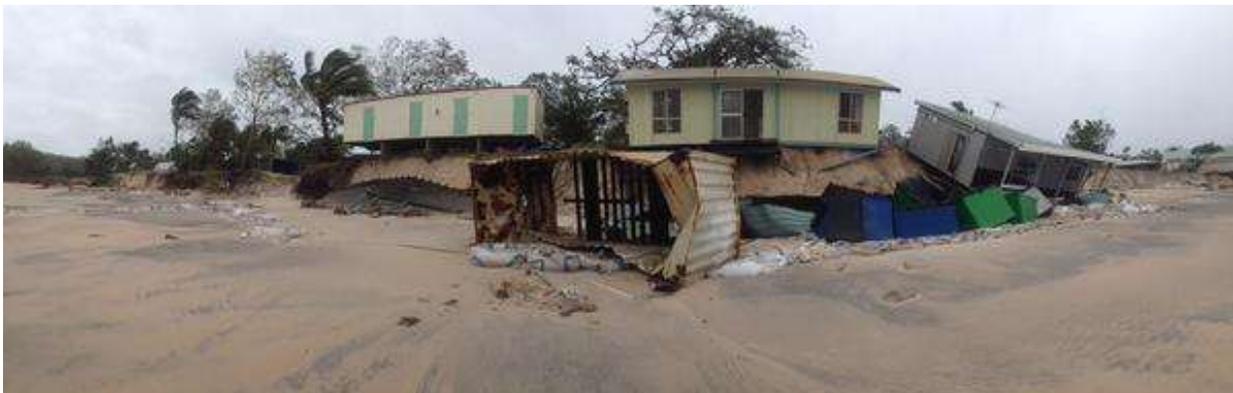
**Figure 5.** Beach erosion in Great Keppel Island (Photo from [Pierre Jayez](#))

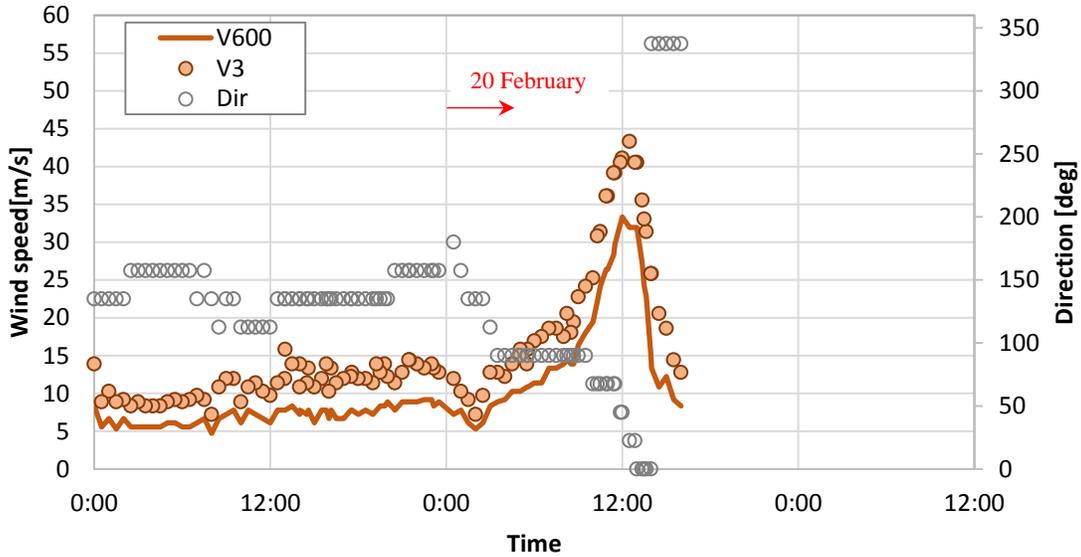
**Figure 6.** Wind speed and direction time histories from the weather station at Yeppoon. The single peak in the wind speed time history indicates the eye did not pass directly over the weather station.

Yeppoon is a town on the coast of Queensland with a population of 13,500. With its beaches and access to the barrier reefs, its industry is primarily driven by tourism. The eye of Cyclone Marcia passed less than 16 km from the town around 12 PM on 20 February. Sustained wind speeds (V600) of 120 km/h and gusts (V3) of 156 km/h were recorded by the local Yeppoon weather station, which reflect a Category 2 cyclone. The time histories of the wind speed and direction are shown in Figure 6. The atmospheric pressure and temperature as Marcia passed by are shown in Figure 7.

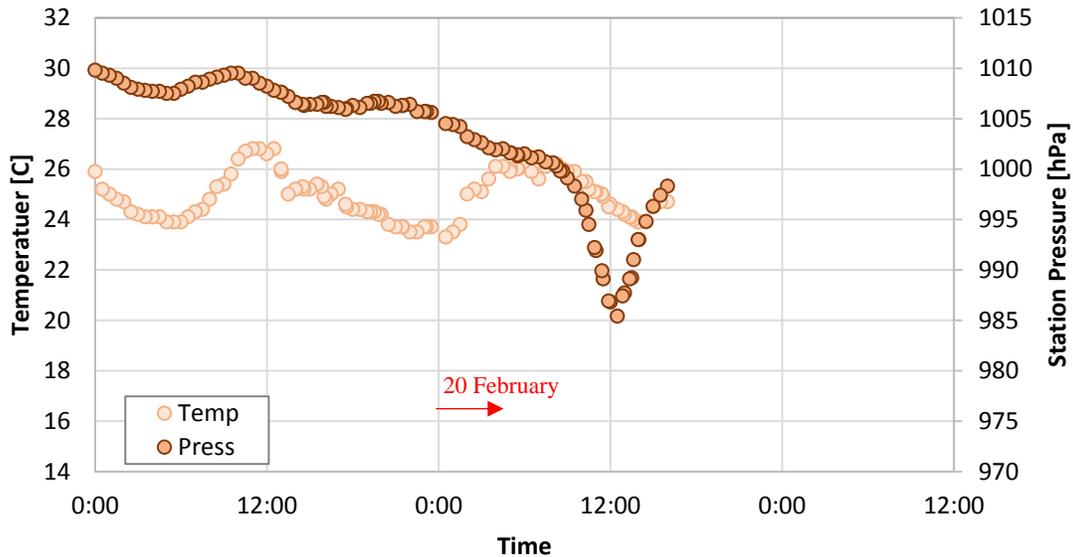
**Figure 7.** Temperature and atmospheric pressures recorded at the Yeppoon weather station during the passage of Tropical Cyclone Marcia.

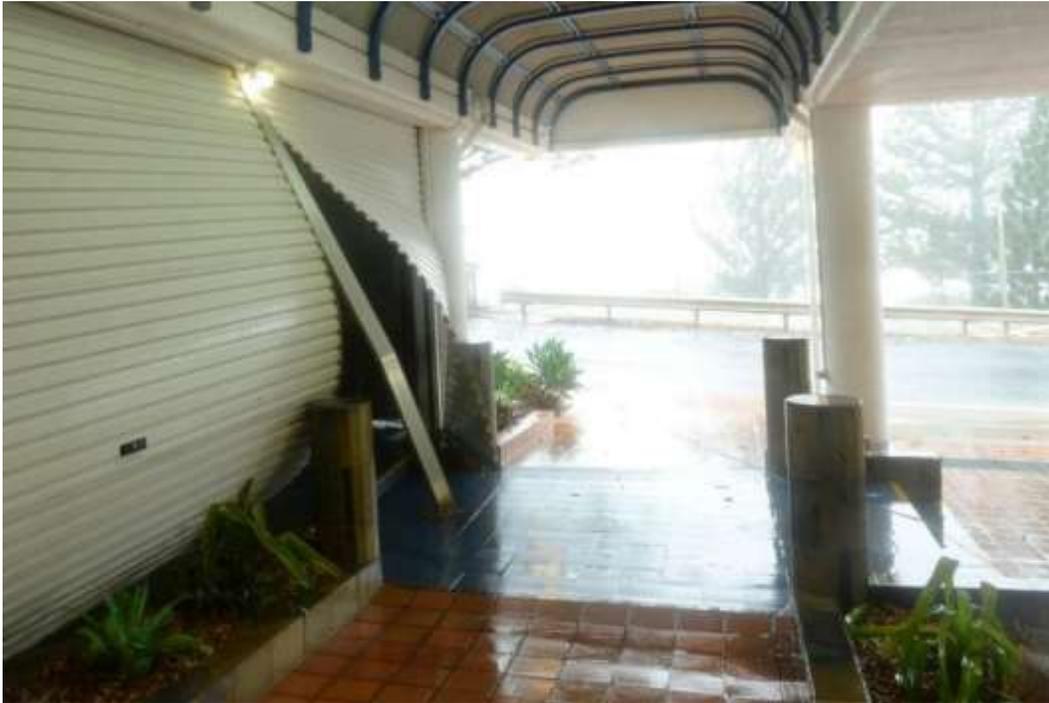
No estimates of the total number of homes damaged is available at the time of this report, but the photos and videos that have emerged on social media and local news indicate significant structural damage has been suffered by some properties (mostly to older house construction). Figure 8 shows a roller door blown outward at Yeppoon Hotel, Figure 9 shows a home with roof

**Figure 8.** Roller doors blown outward at Yeppoon Hotel (Google Images)

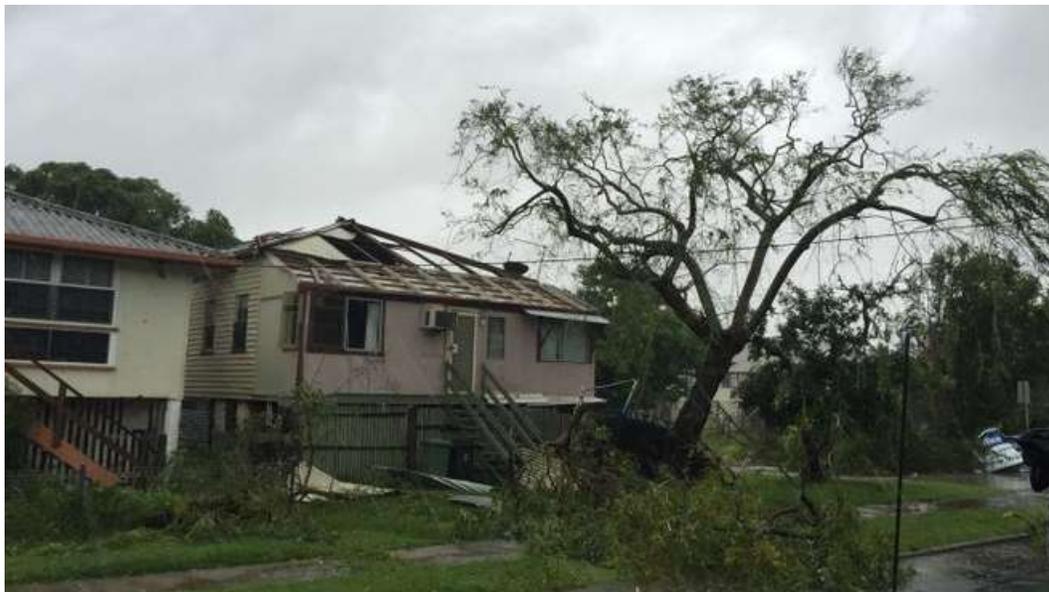
**Figure 9.** Batten and cladding damage in Yeppoon (pre-1960's house) (ABC News)

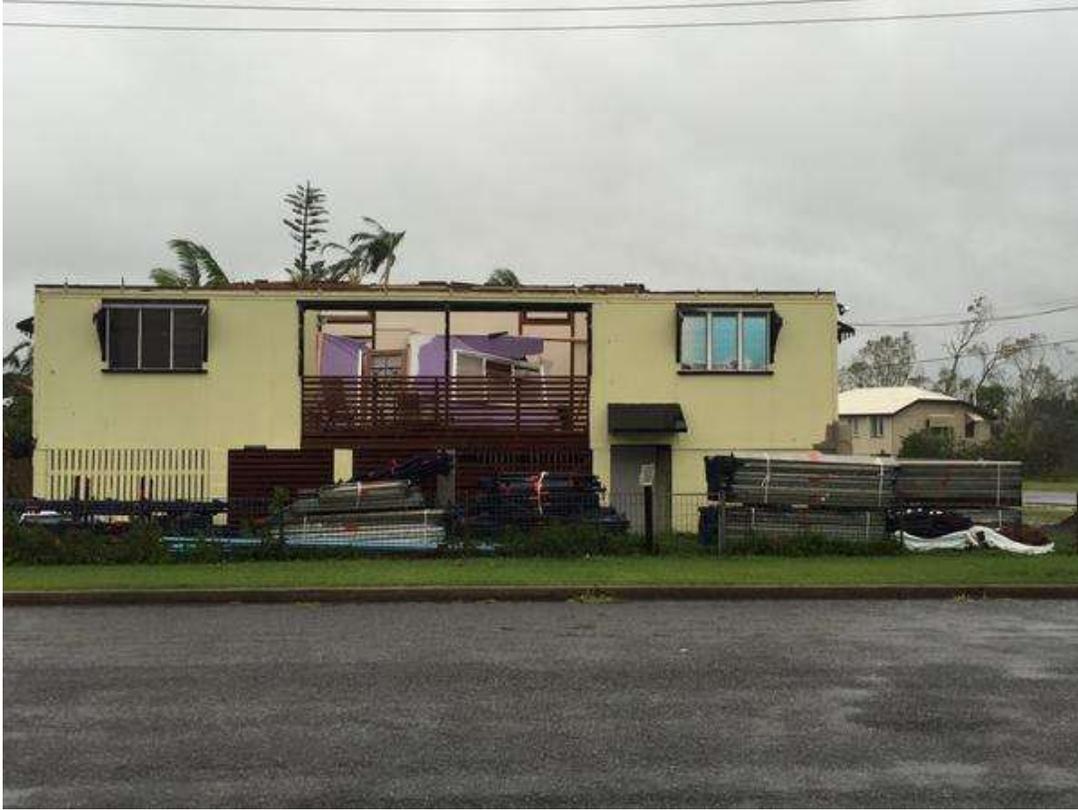
batten and cladding damaged, Figures 10-11 show homes with a missing roof, and Figure 12 shows a home with the roof removed by the wind and exterior walls collapsed.

**Figure 10.** Fibro house (est. pre-1970's) with missing roof in Yeppoon (ABC News)

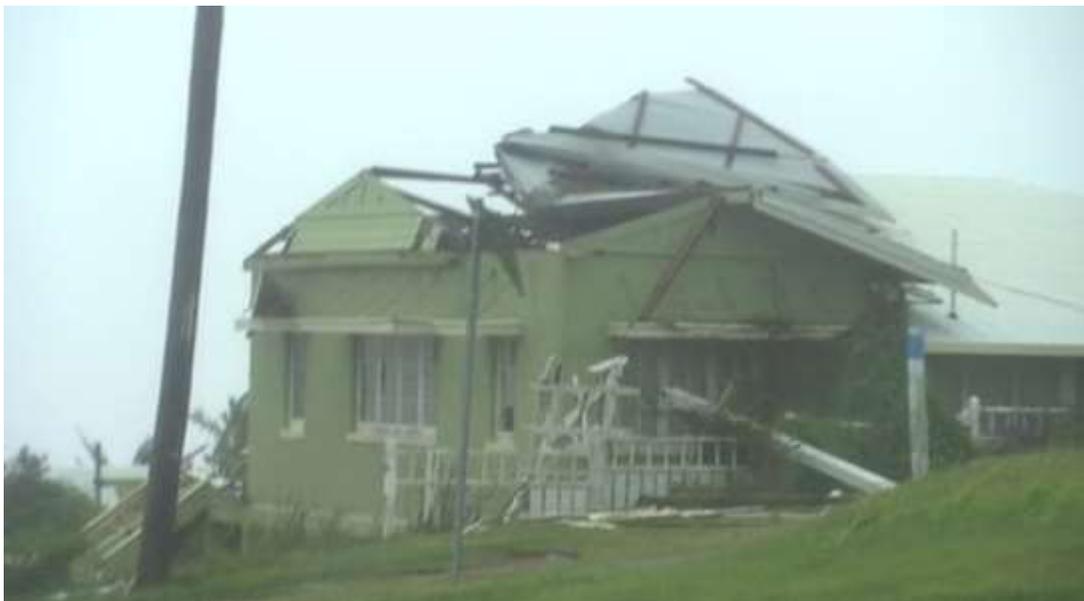
**Figure 11.** Roof damage to a home in Yeppoon caused by Tropical Cyclone Marcia. Photo courtesy of 7News Brisbane.

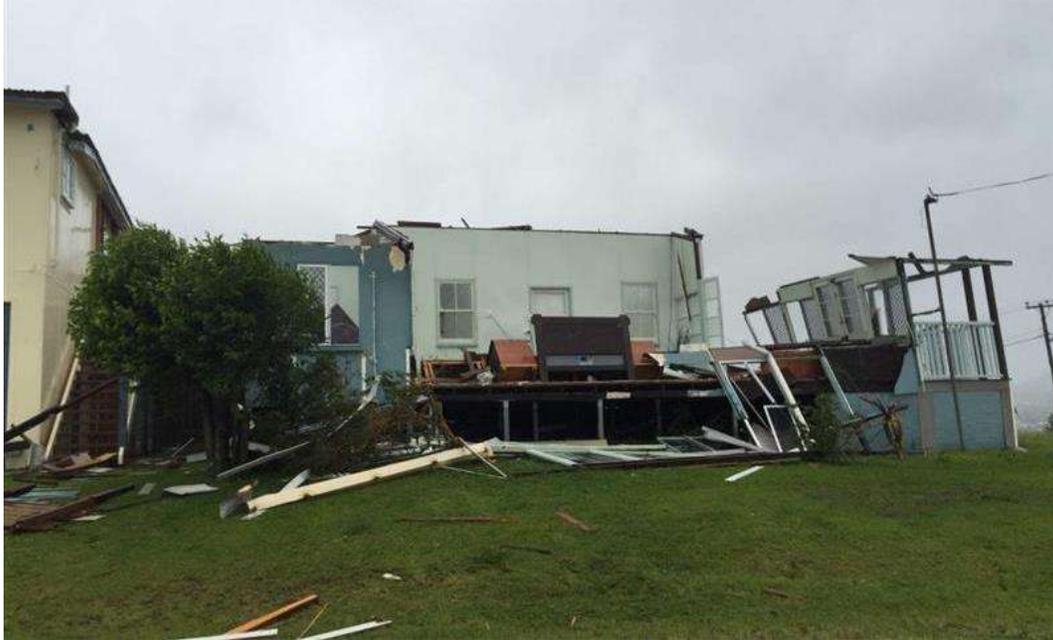
**Figure 12.** Roof removed and exterior walls collapsed in a home in Yeppoon. (ABC News)

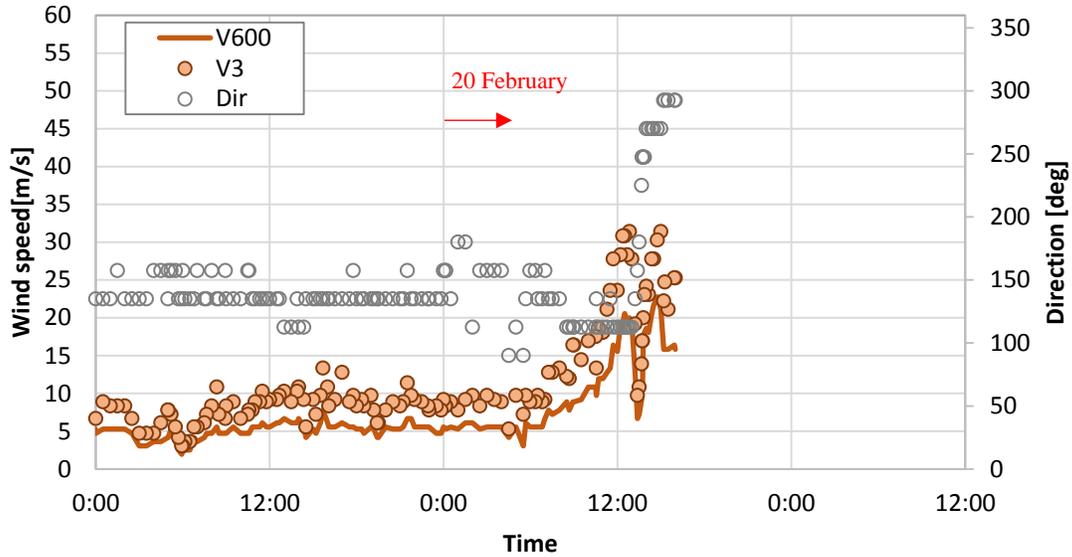
**Figure 13.** Wind speed and direction time histories recorded by the Rockhampton weather station. Note the two peaks in the wind speeds, indicating that the eye passed directly over the weather station.

Rockhampton is a city and local government in Queensland with a population of 82,550 as of 2013. It is located 38 km Southwest of Yeppoon. Rockhampton has a significant number of governmental, community and major business offices for the coastal region of Queensland. The economy is primarily driven by the beef industry. The BOM categorized Tropical Cyclone Marcia as a Category 3 as it passed over Rockhampton. However, the maximum sustained wind speeds (V600) recorded by the local weather station were 82 km/h, with gusts (V3) of 113 km/h. The time histories of wind speed and direction are shown in Figure 13. The pressure and temperature are given in Figure 14.

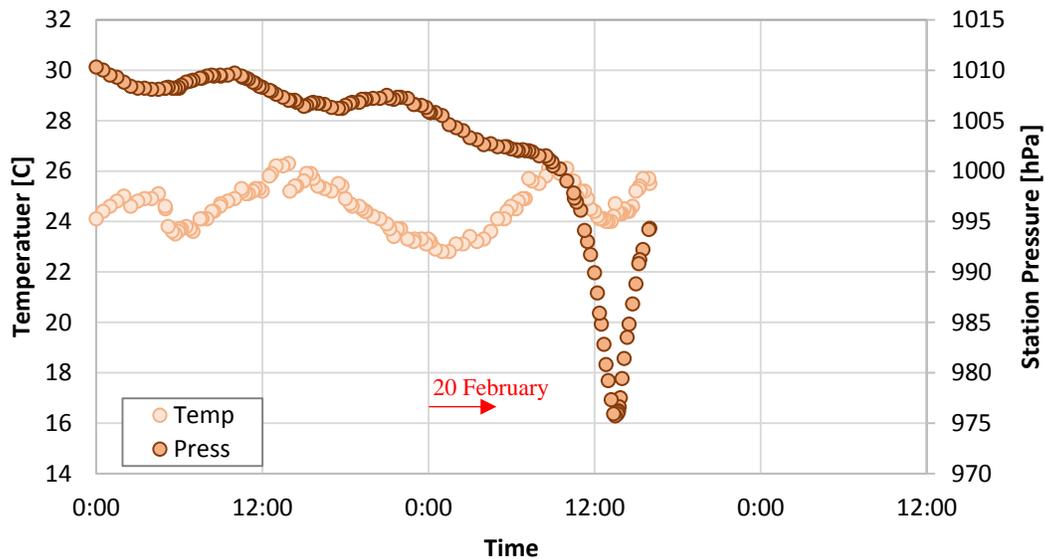
**Figure 14.** Temperature and static pressure during the passage of Tropical Cyclone Marcia. The sharp decrease and increase in pressure also indicates the passage of the eye over the weather station.

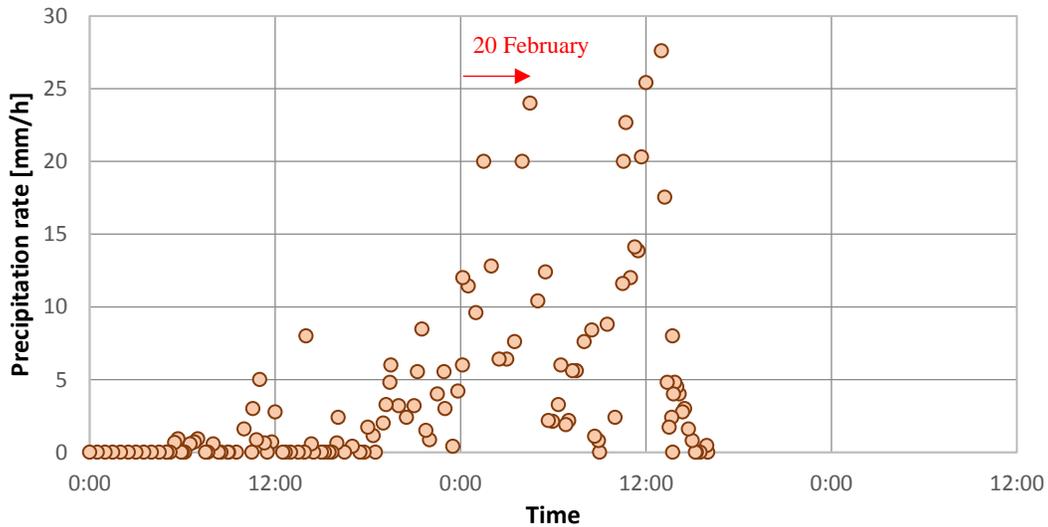
shows the rainfall intensity during the passage of Tropical Cyclone Marcia, peaking at 30 mm/h just after passage of the eye.

**Figure 15.** Rainfall intensity rates measured by the Rockhampton weather station as Tropical Storm Marcia passed directly over.

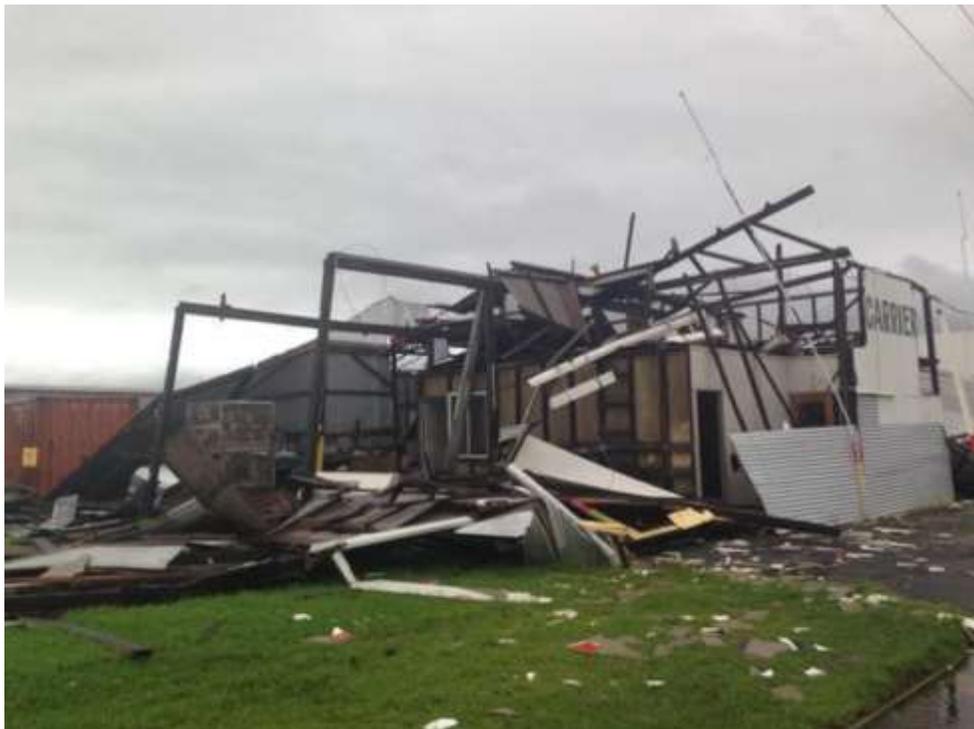
At the time of this report, the extent of the wind damage to Rockhampton is still being assessed. Figure 16 shows a local business with significant damage to the structure of the building. Apart from the structural damage, there were numerous reports of flooding and road closures.

**Figure 16.** Structural damage to local business in Rockhampton. Courtesy [Louisa Rebgetz](#).
