Are our homes and buildings failing us? Excessive damage and loss during cyclones

Darwin - Cyclone Tracy

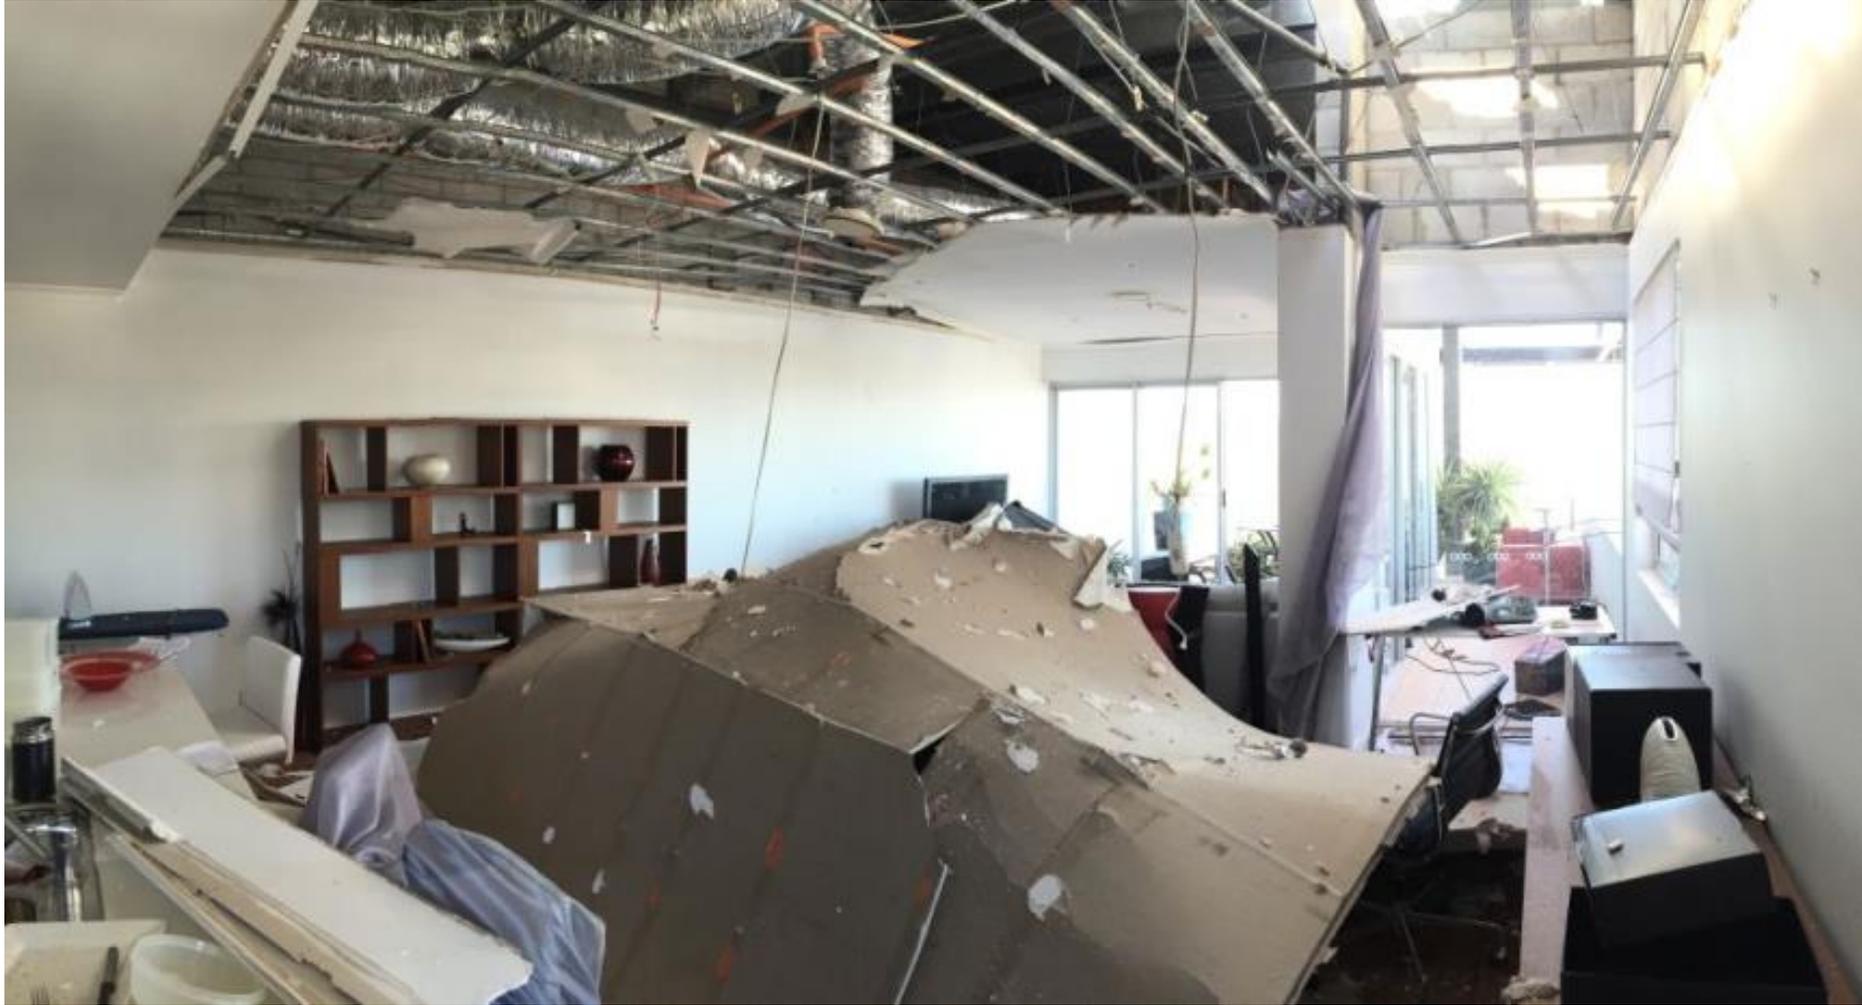
Internal damage from pressurised ceiling space

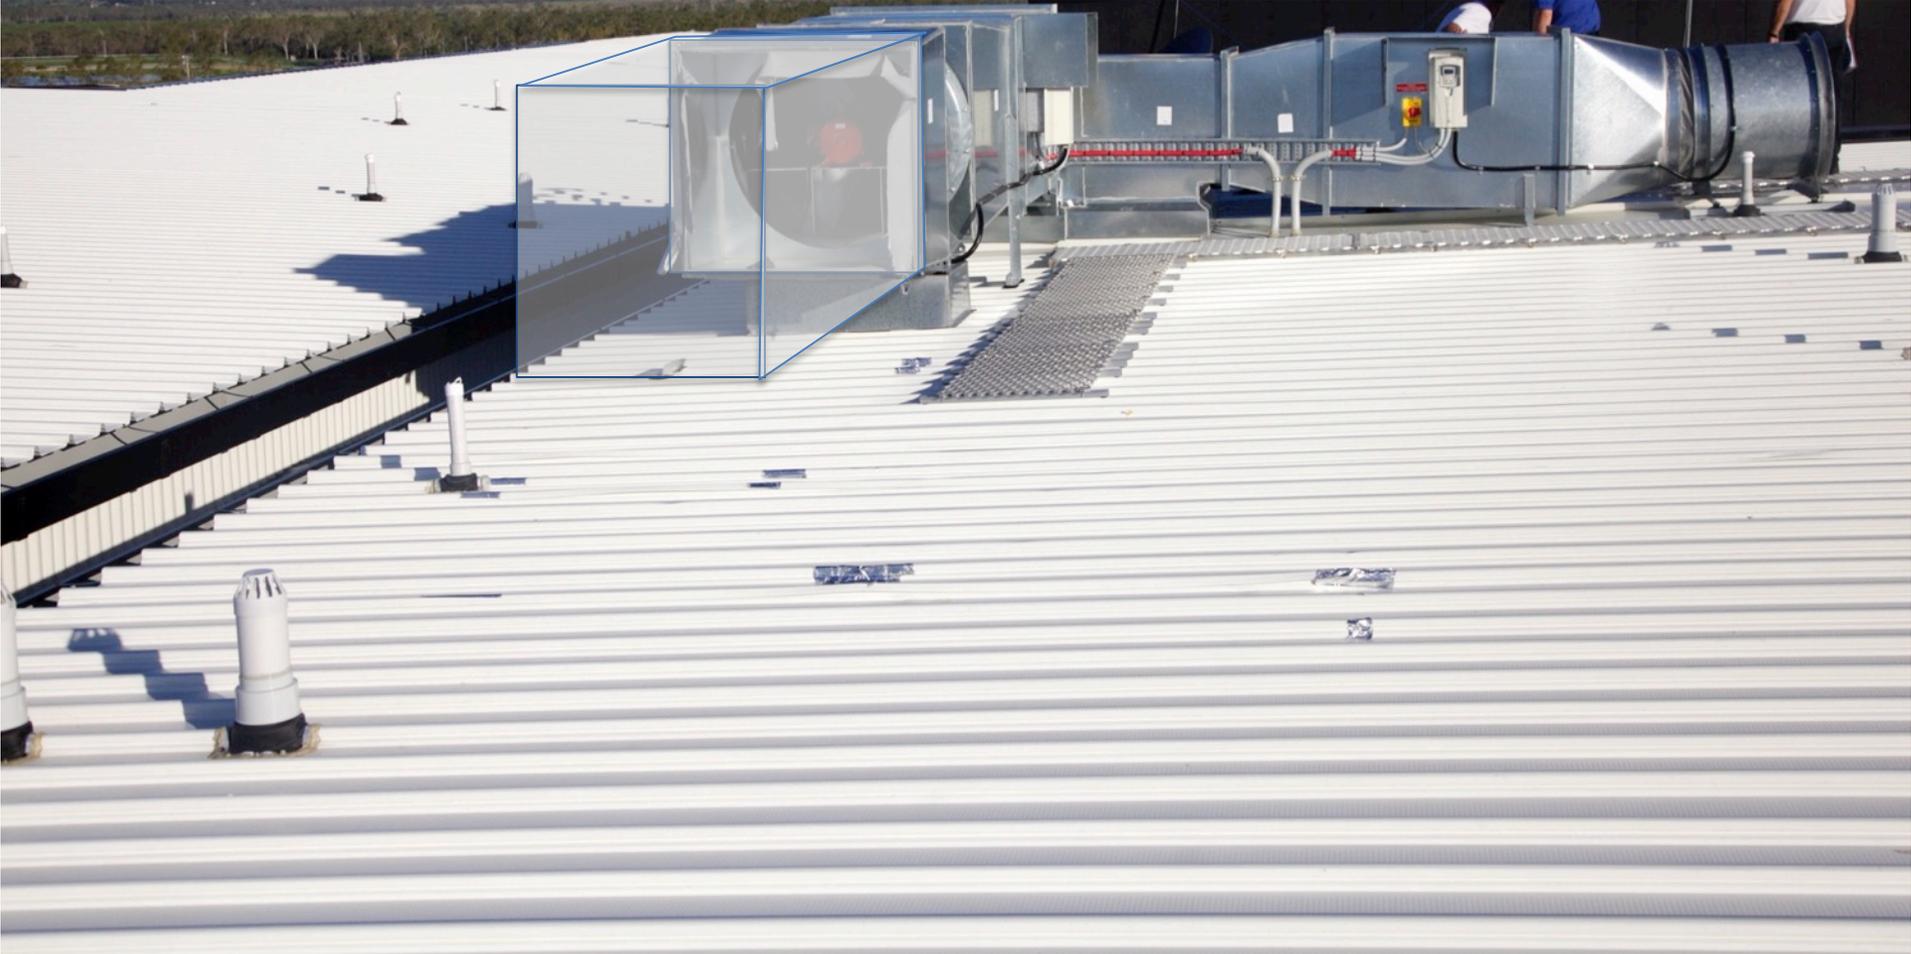
A/C Ducting lost

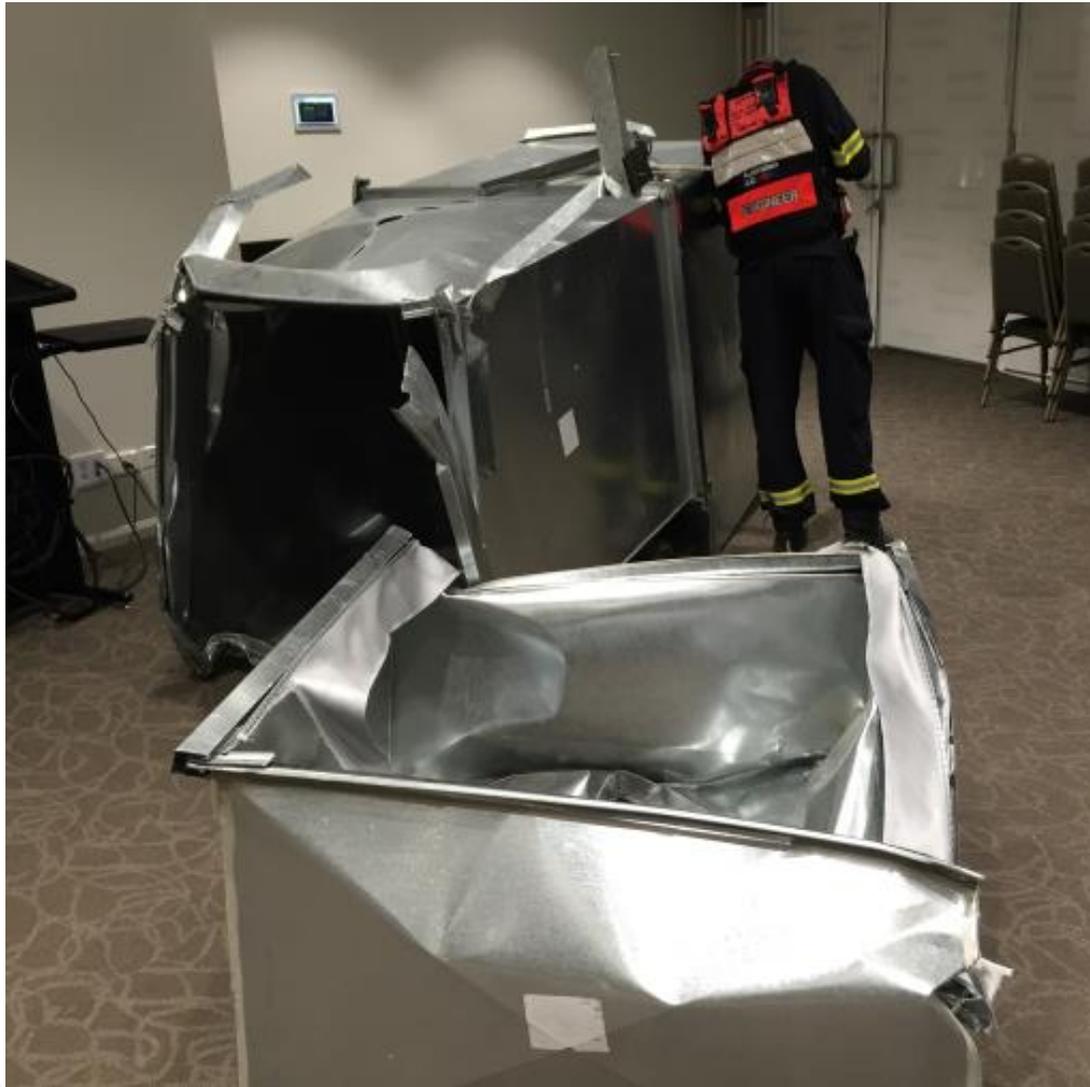
Recovered a/c duct

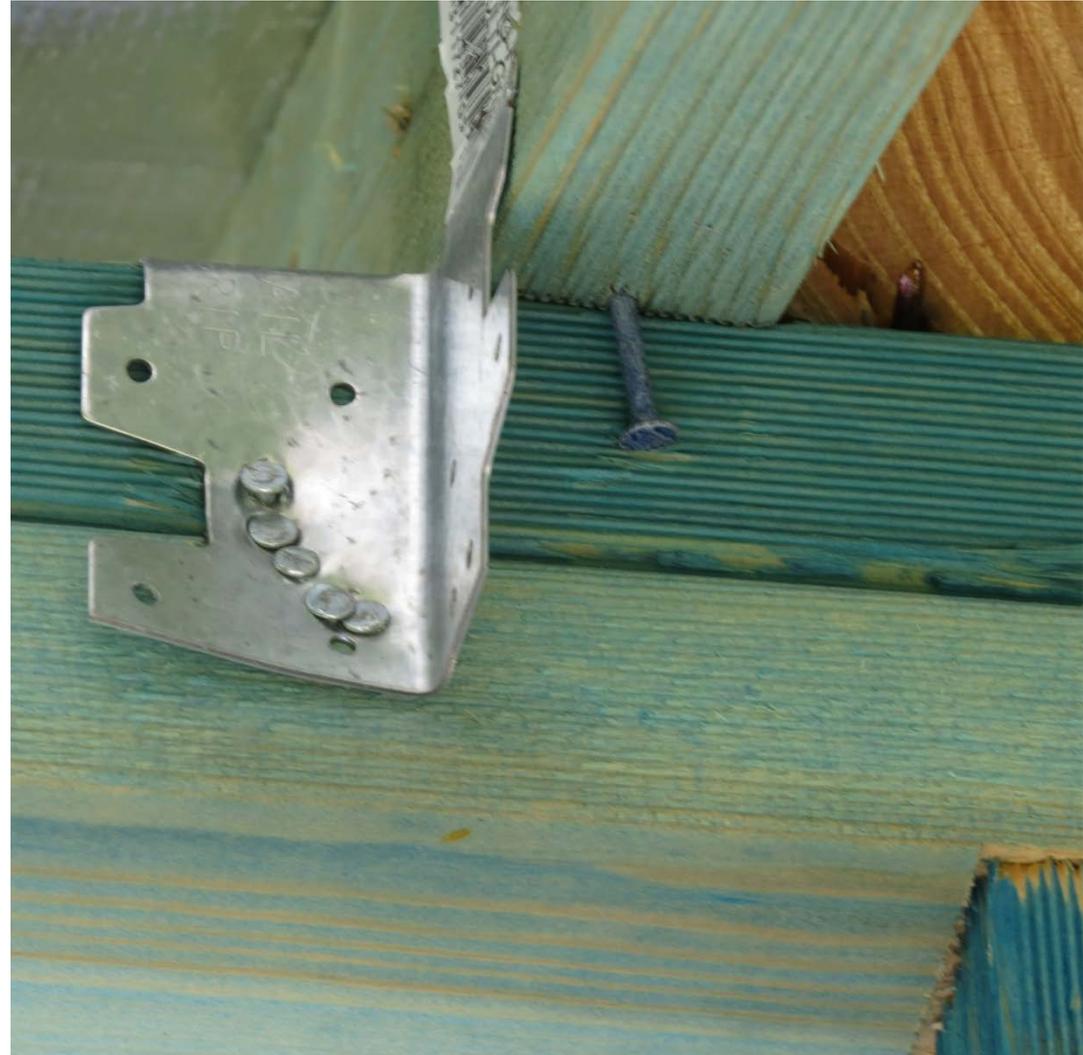
Brisbane housing

Structural load path - Truss tie down

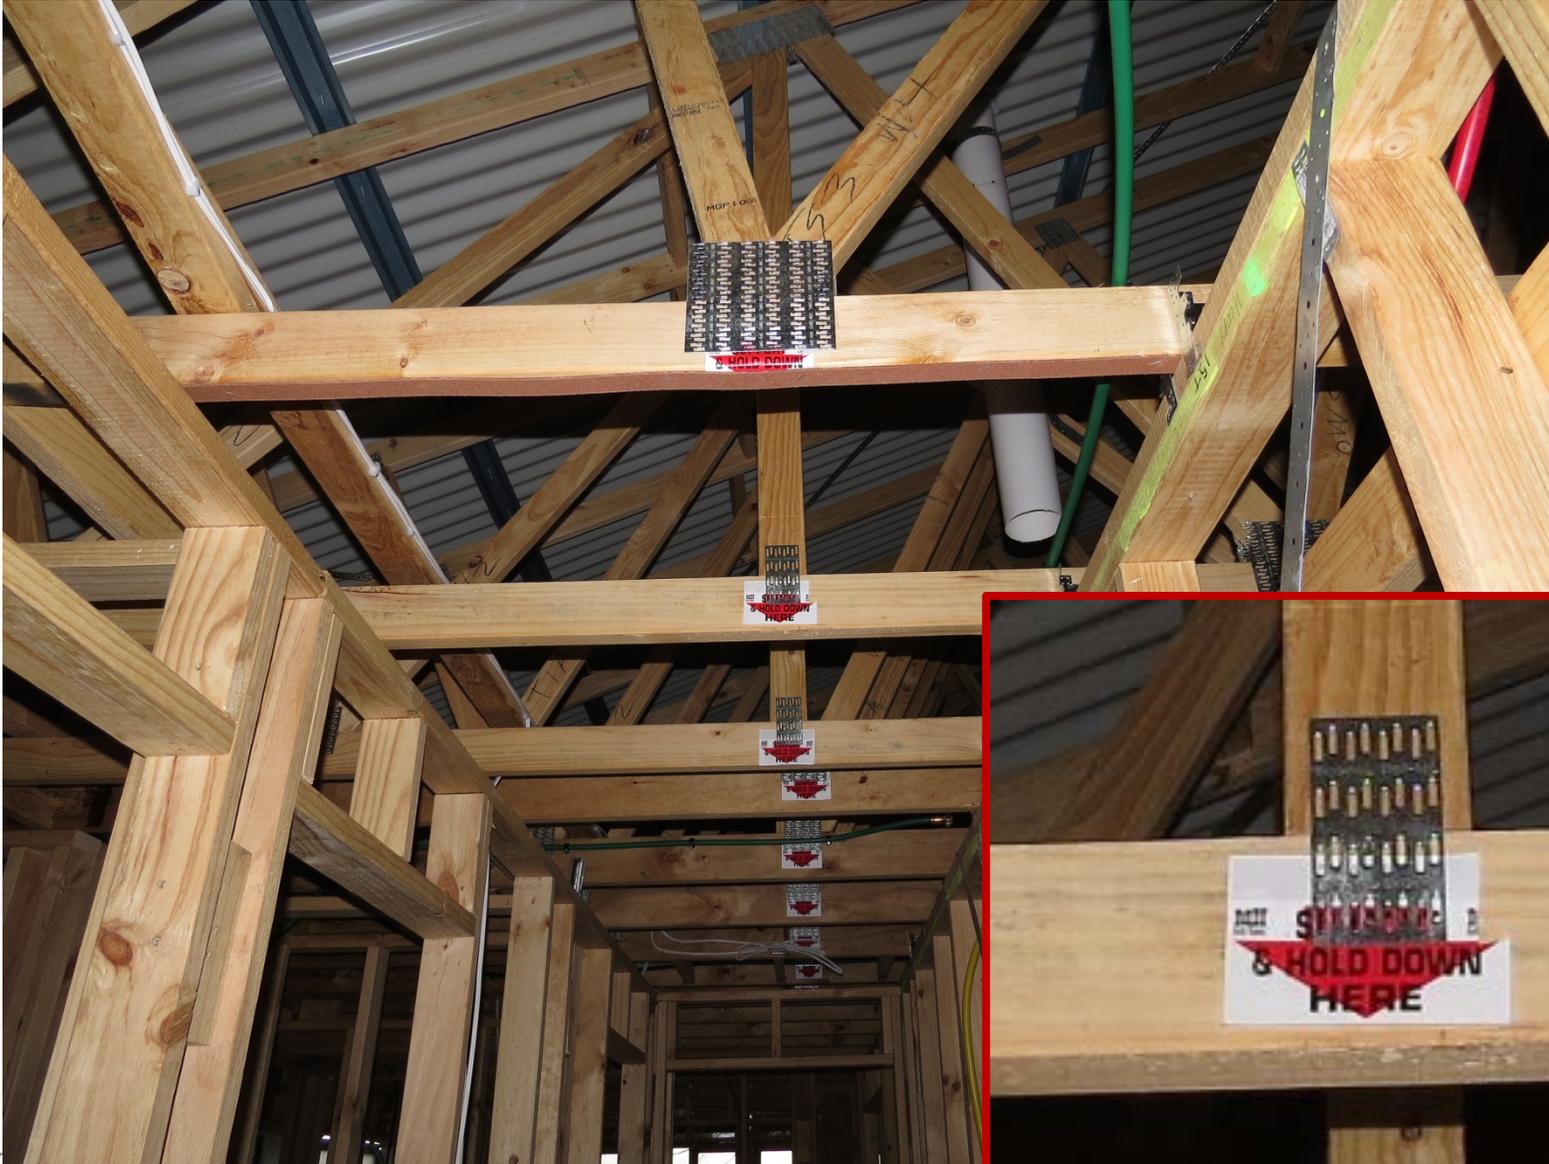
Melbourne housing

Structural load path - Truss tie down
