Large Damage Bills (to buildings) From Cyclones Can Be Reduced By Small Actions

Tropical Cyclone Debbie

Damage to buildings in the Whitsunday Region

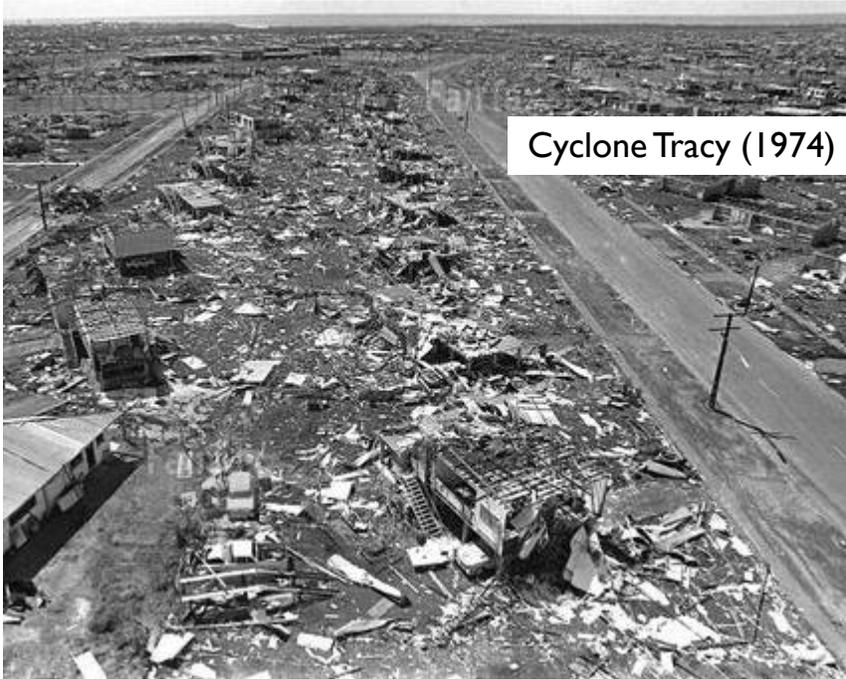
Queensland Home Building Code (1982)

- Peak gust estimated 243 km/h (71 Fatalities)
- 70-90% of housing destroyed
- Engineered structures performed better

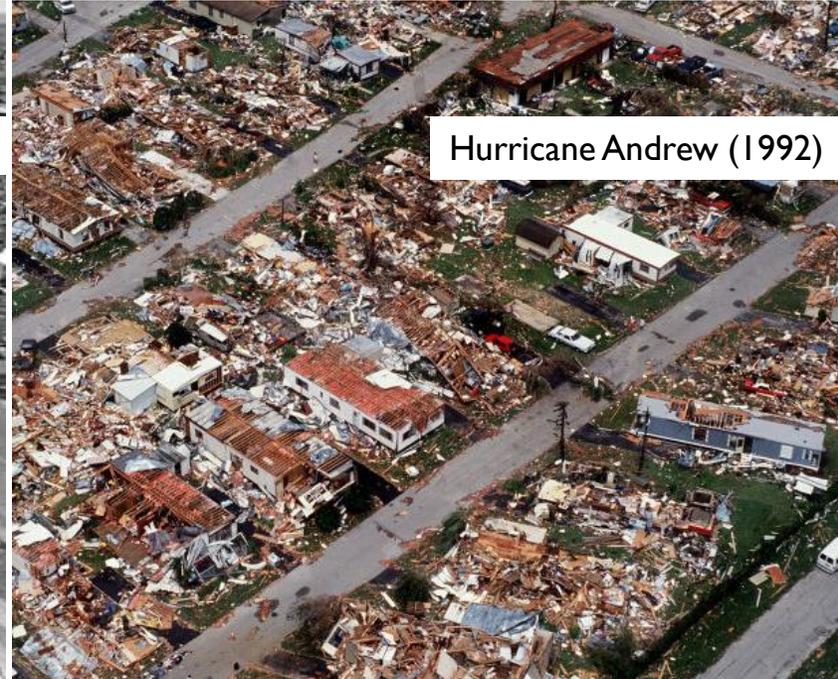
Florida Building Code (2002)

- Peak gust estimated 281 km/h (65 Fatalities)
- >63,000 homes destroyed

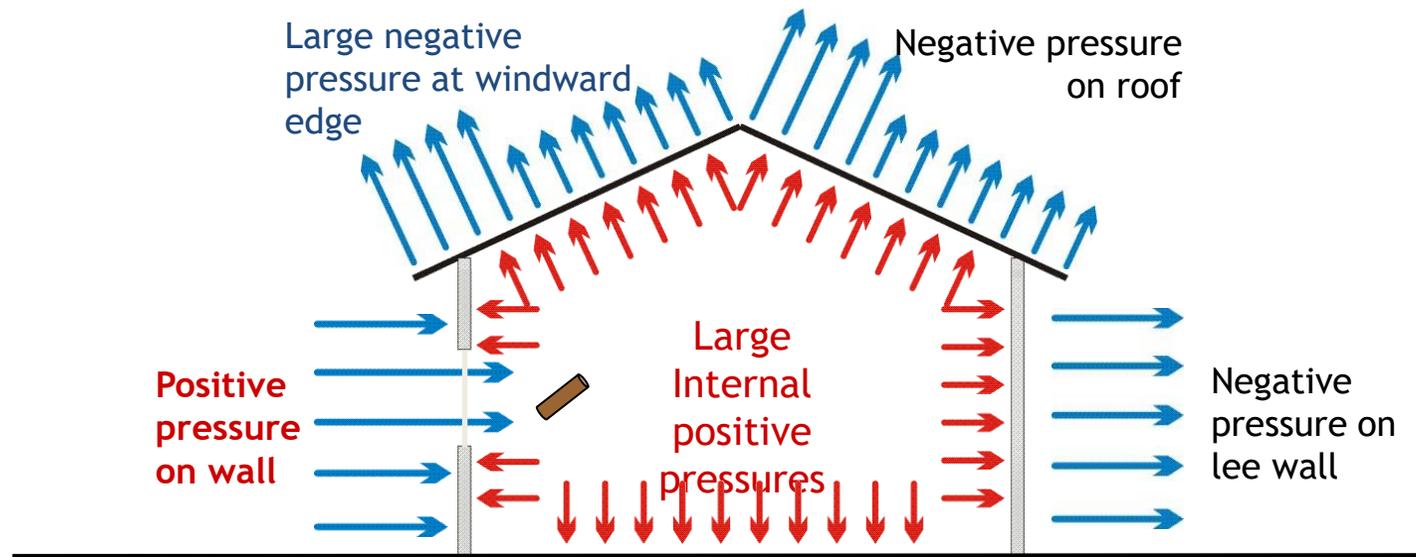
If an opening forms in the external envelope of the building
e.g. a window is broken or a door blows in...

Housing design standard AS4055 requires that a dominant opening is assumed in the design. (for cyclonic regions, C and D, only)

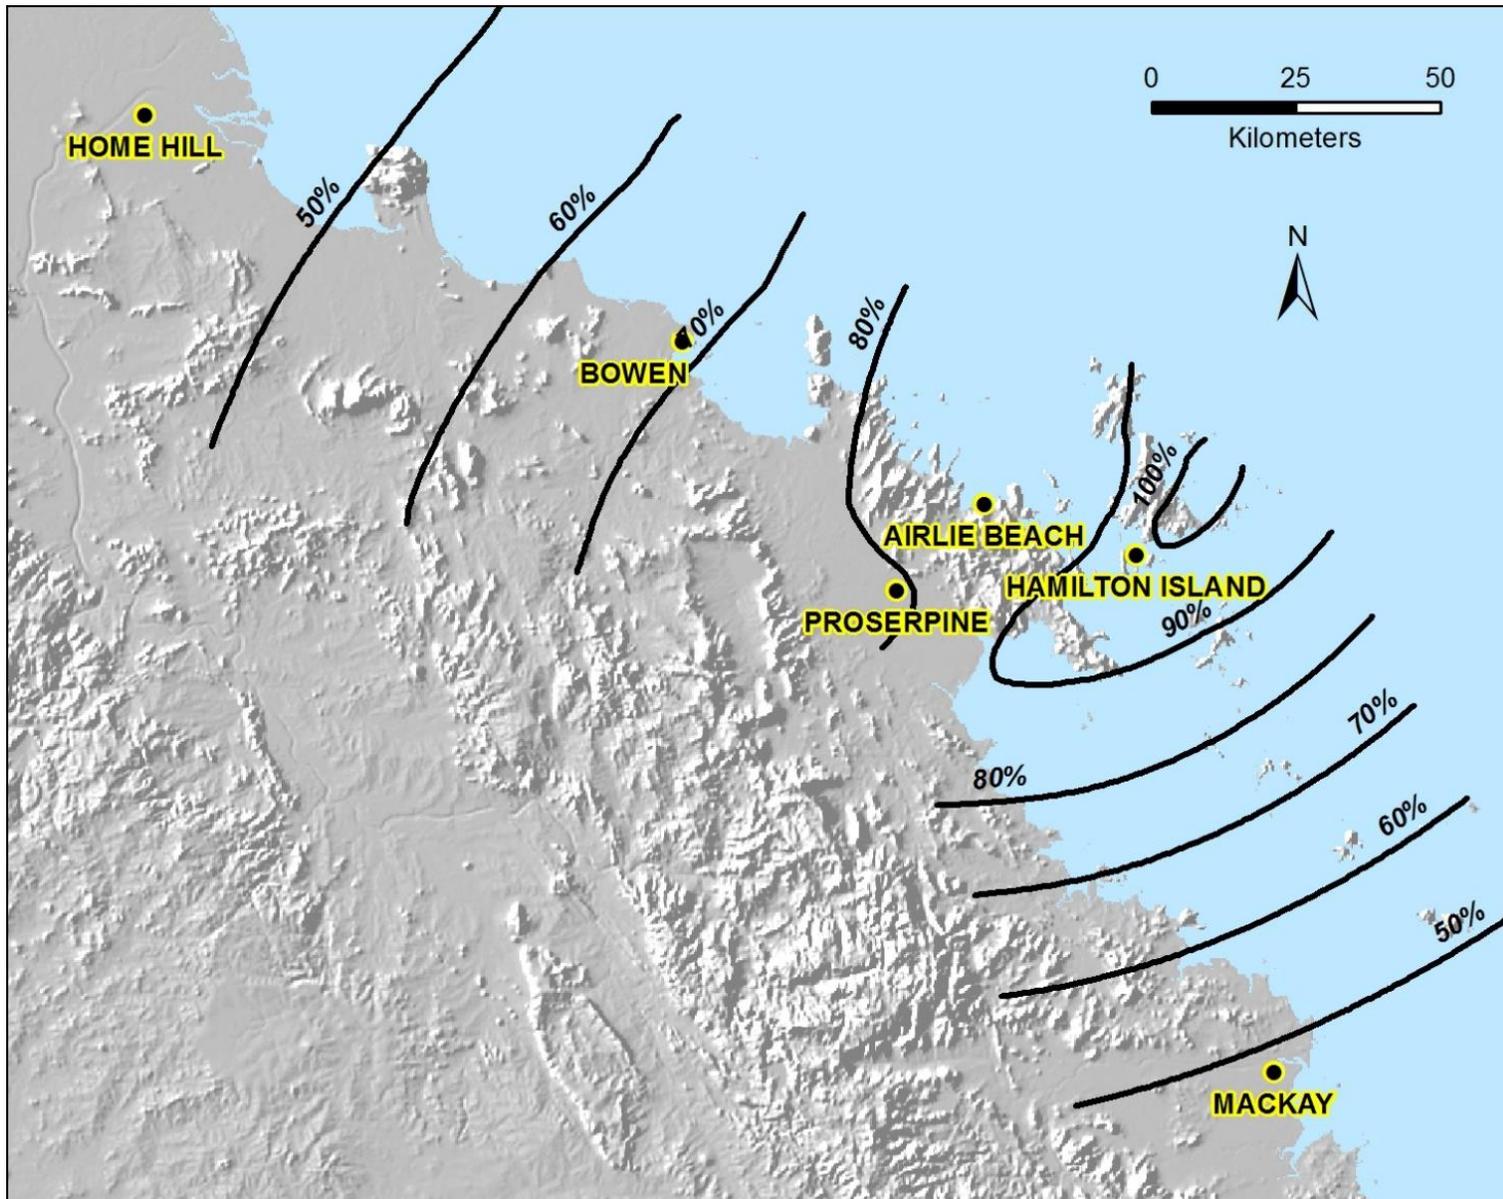
Estimate of wind speed
as a % of Design (V_{500})

(referenced to 10 m
height in open terrain)

Wind at specific buildings
will be influenced by
surrounding
hills/shielding/exposure

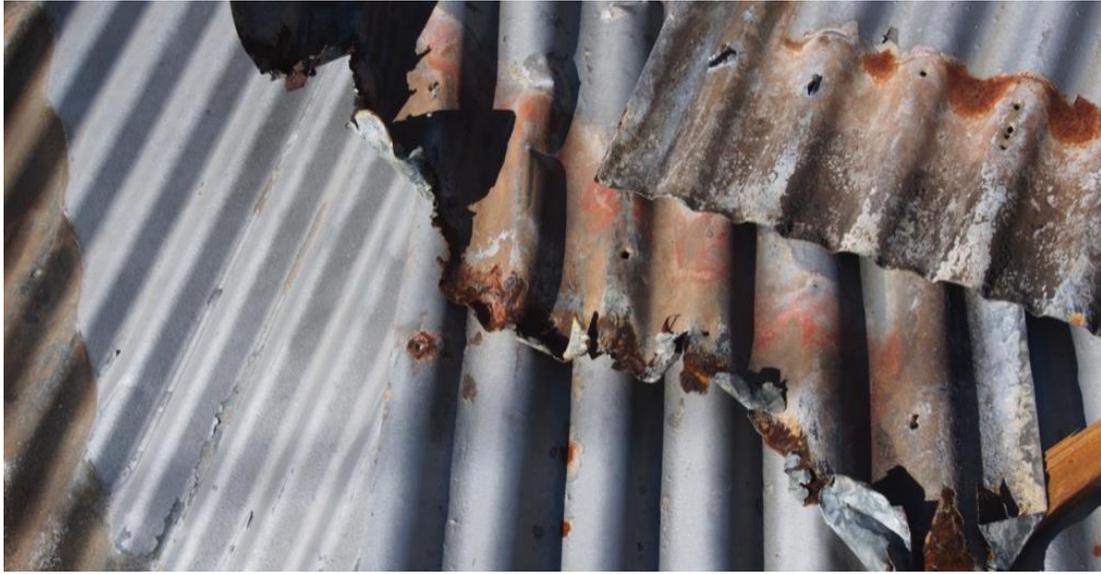
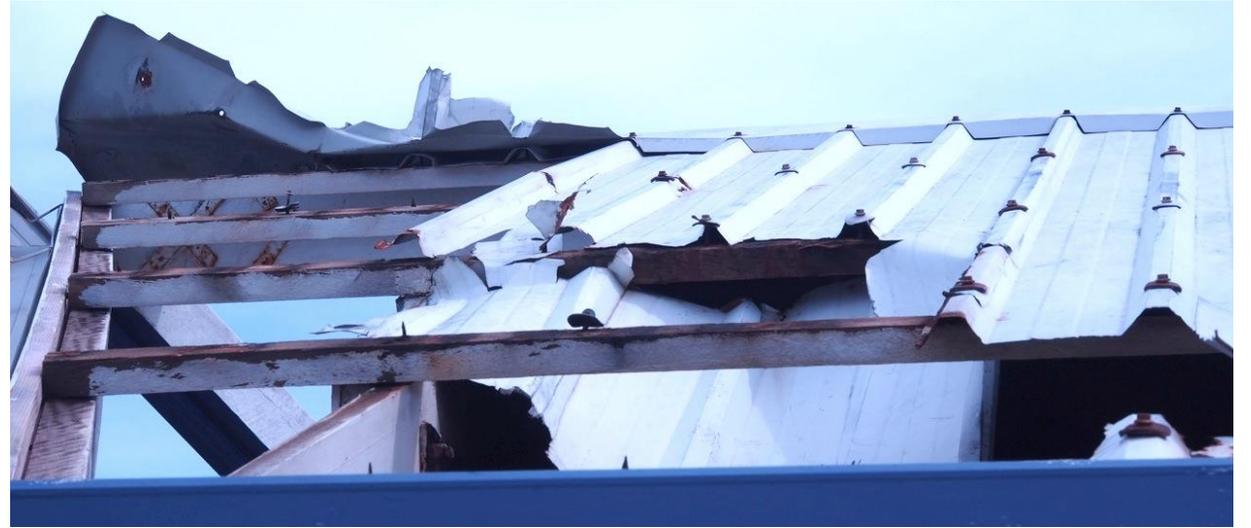
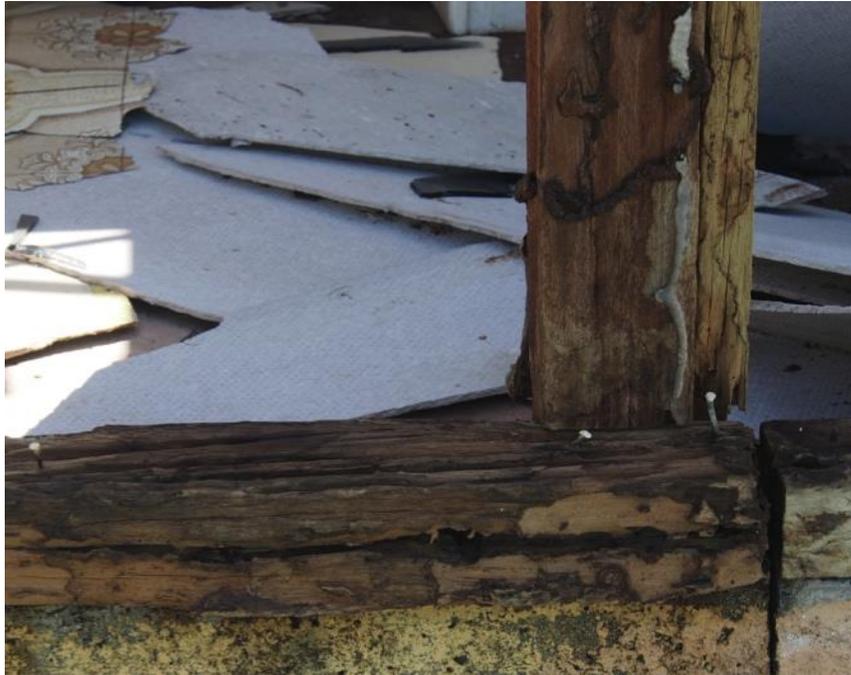
Rust, rot and termites

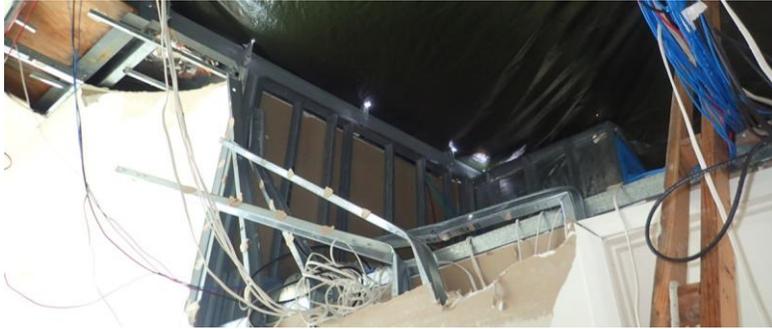
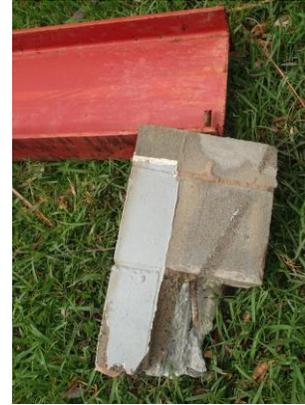
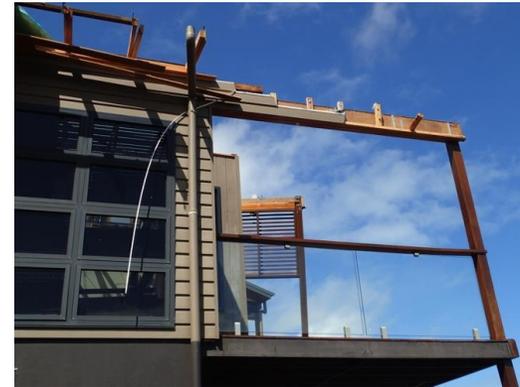
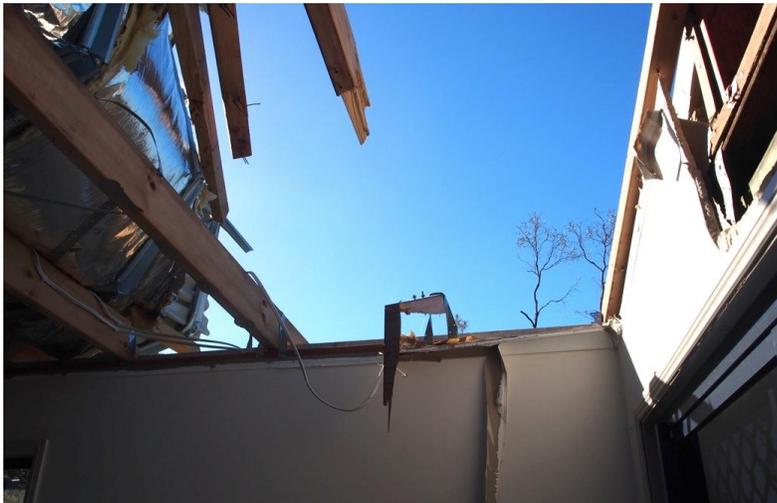
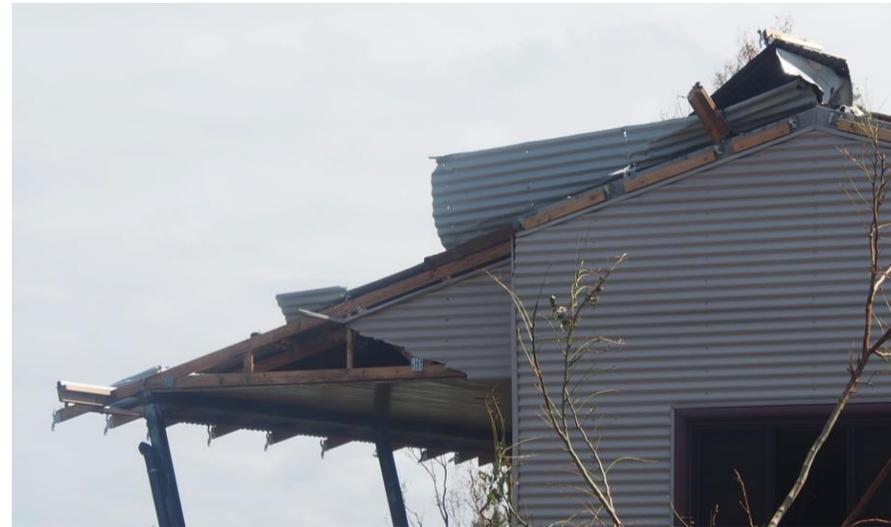
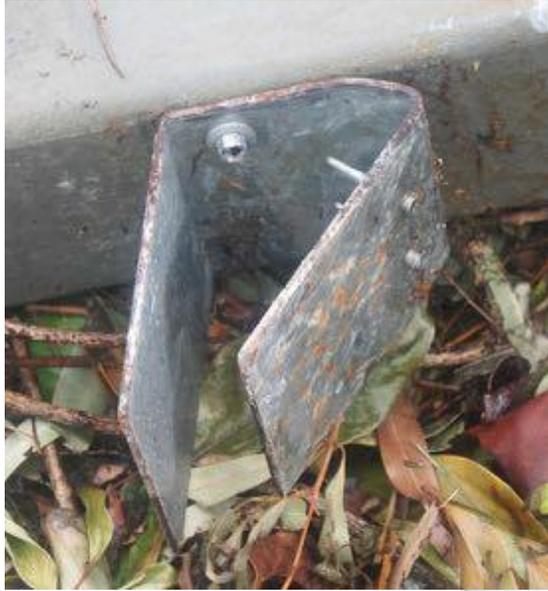
Roof structure damage to contemporary (engineered) construction in Airlie and Hamilton Island

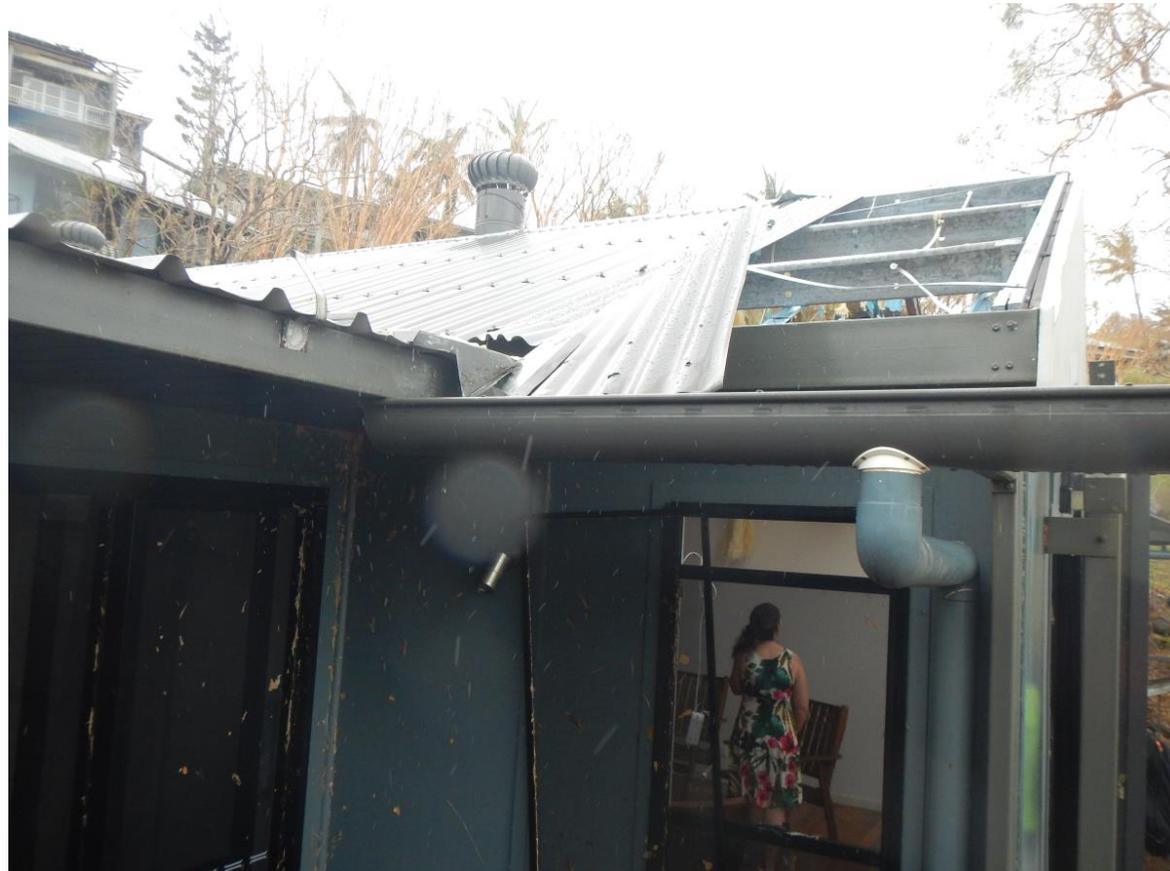
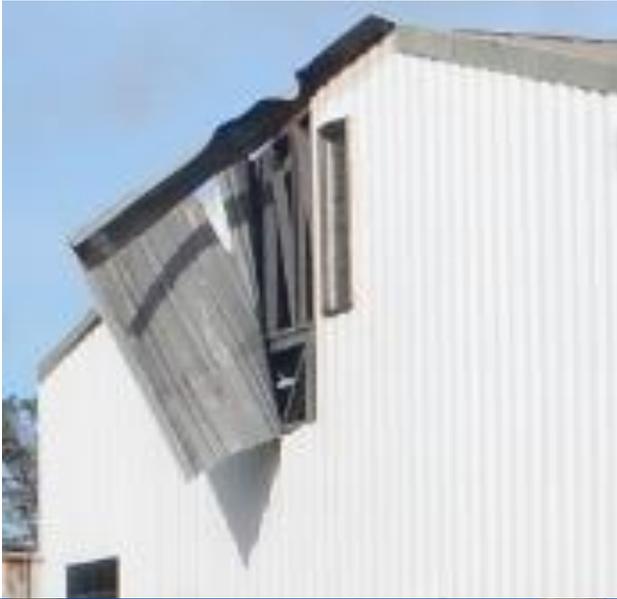
Loss of cladding
elements from
Engineered buildings

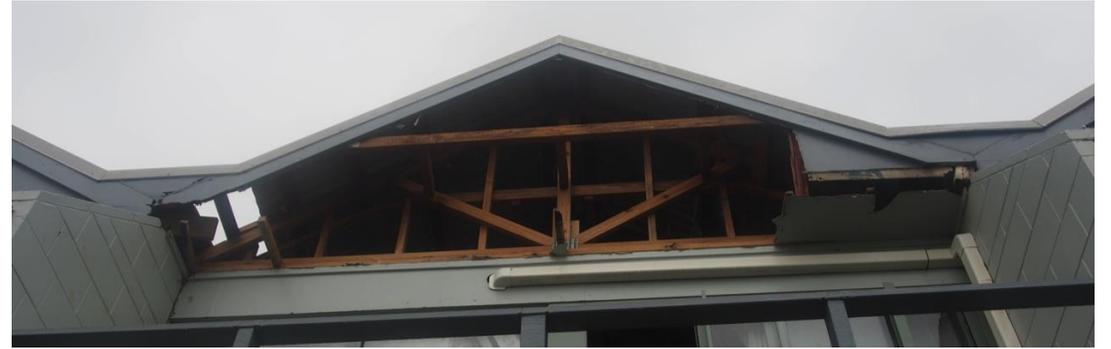
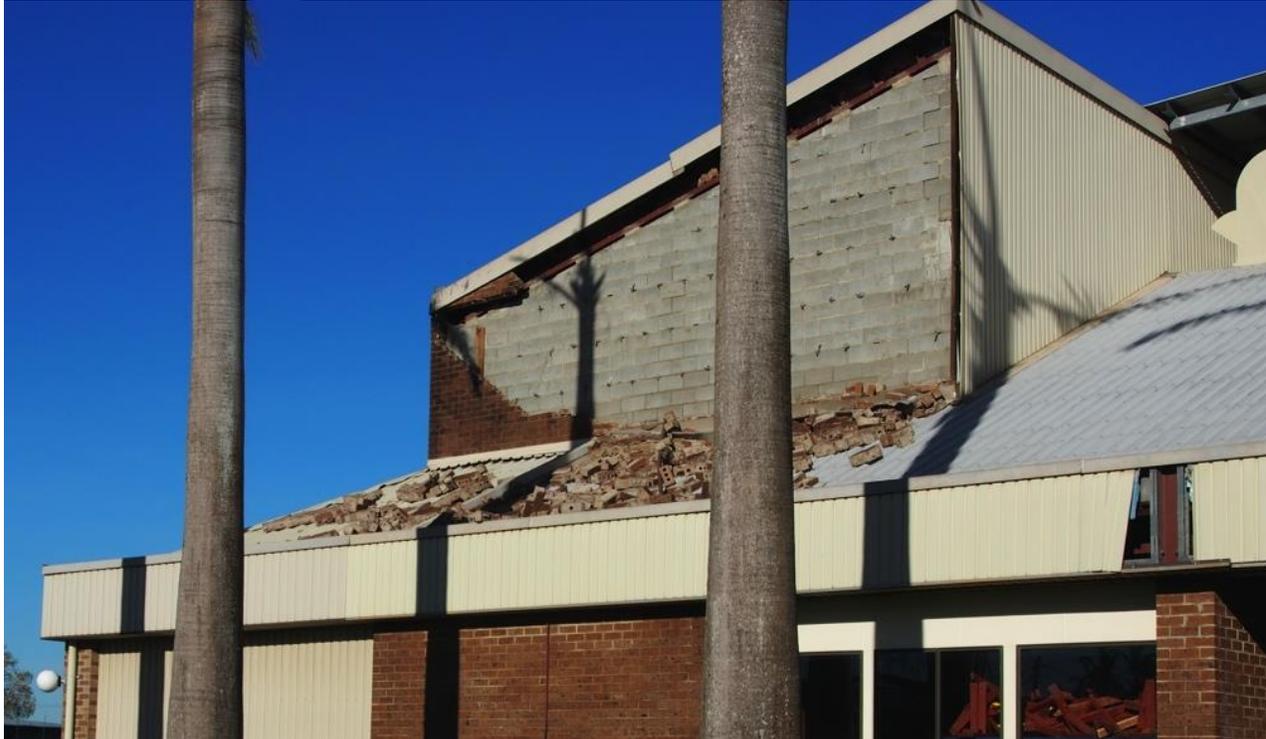
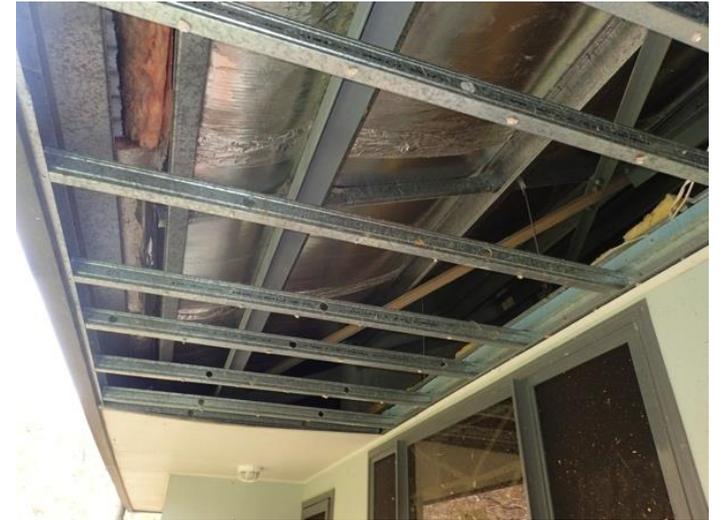
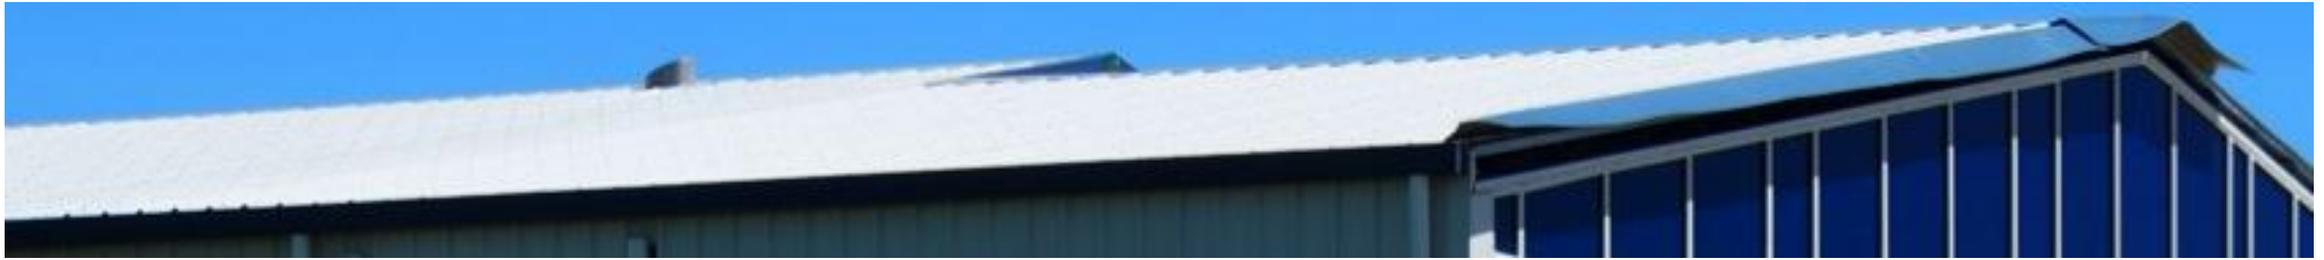
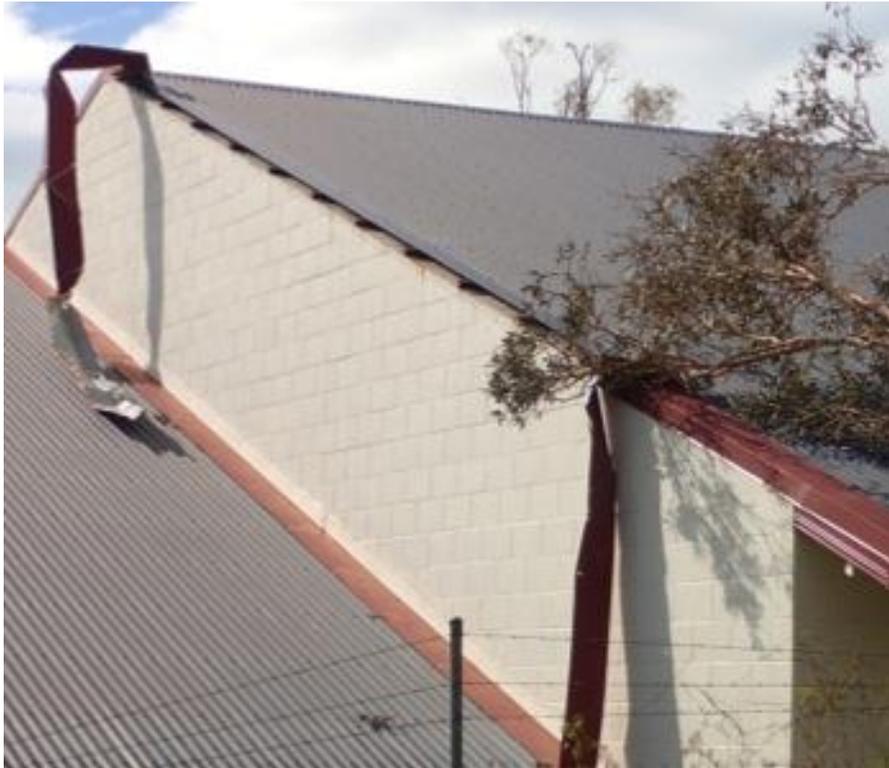
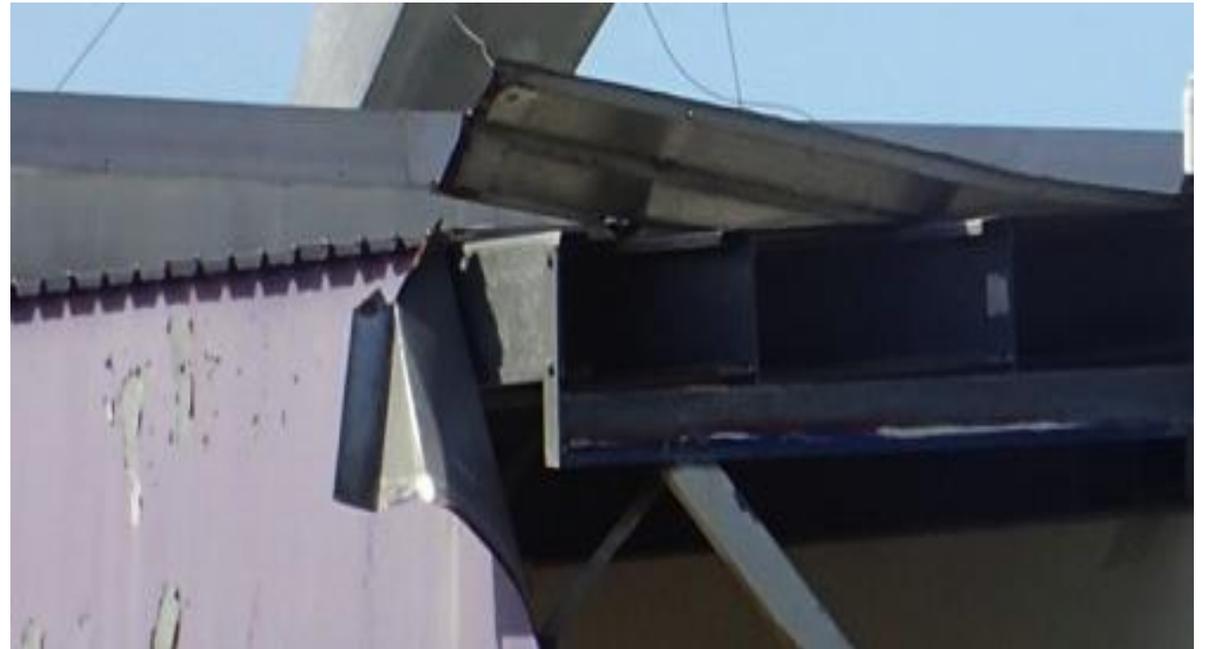
From insurance data → Can be \$1000/m for repair (includes interiors)
(but < \$5/m if build it correct the first time)

Changes to cladding Standard to include to minimum requirements of material, strength, thickness and fastener spacings for all flashings for cyclonic regions

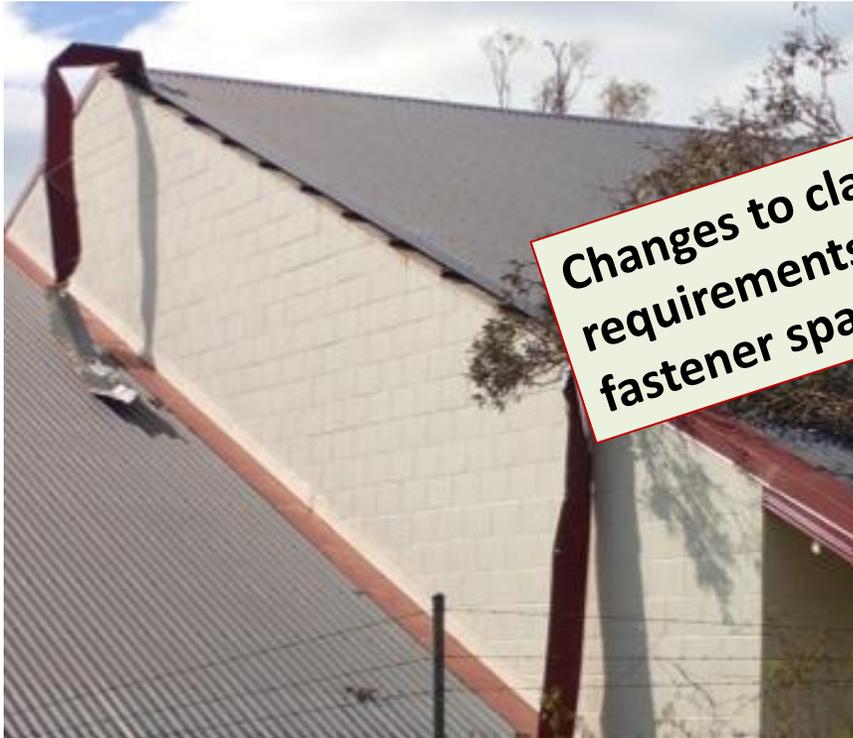
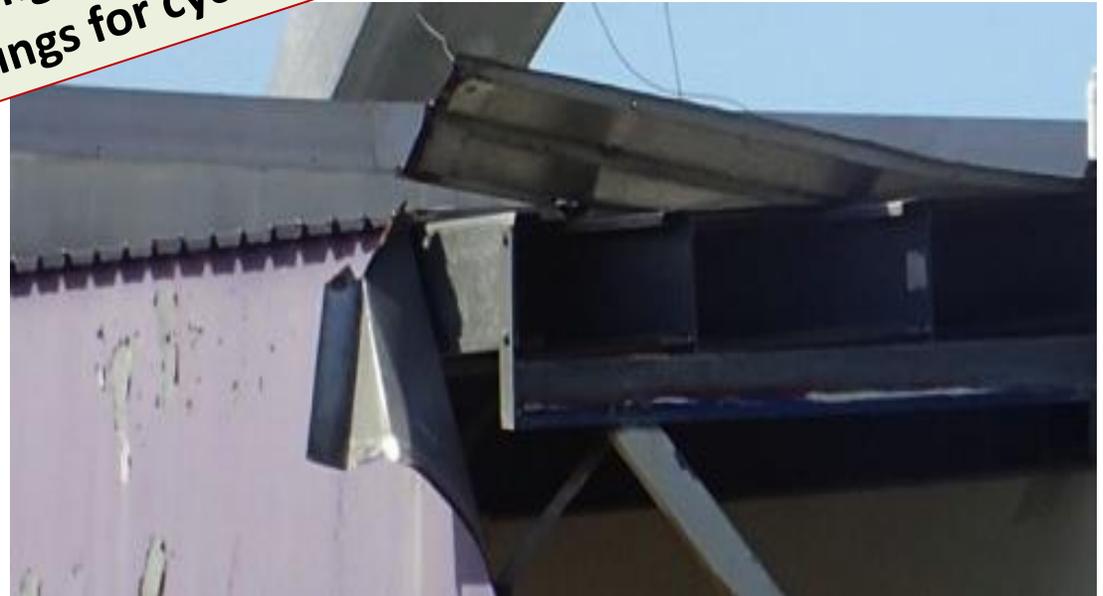
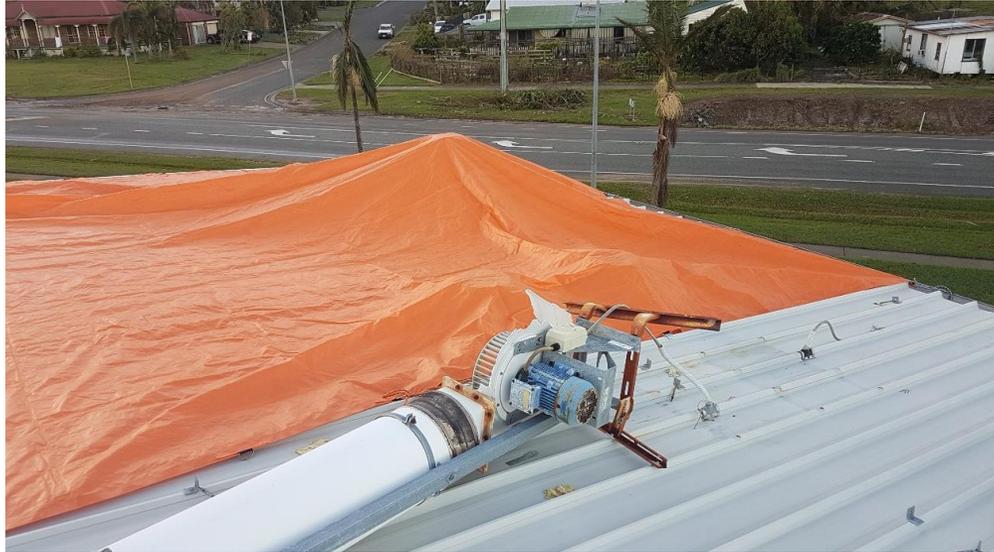
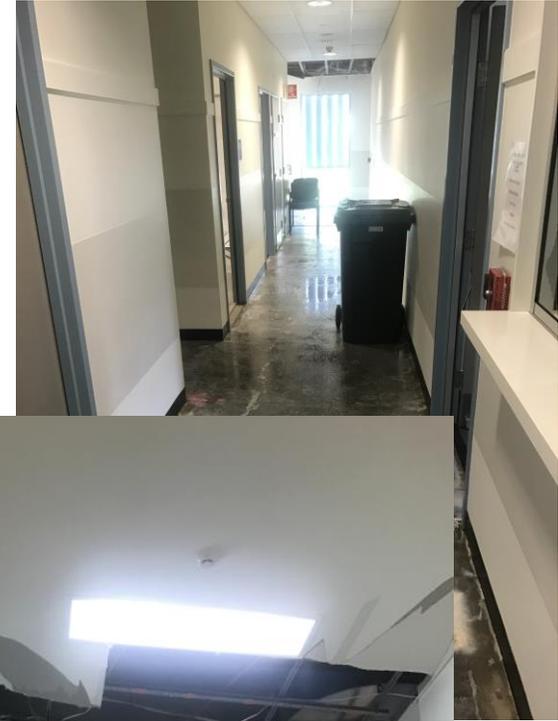
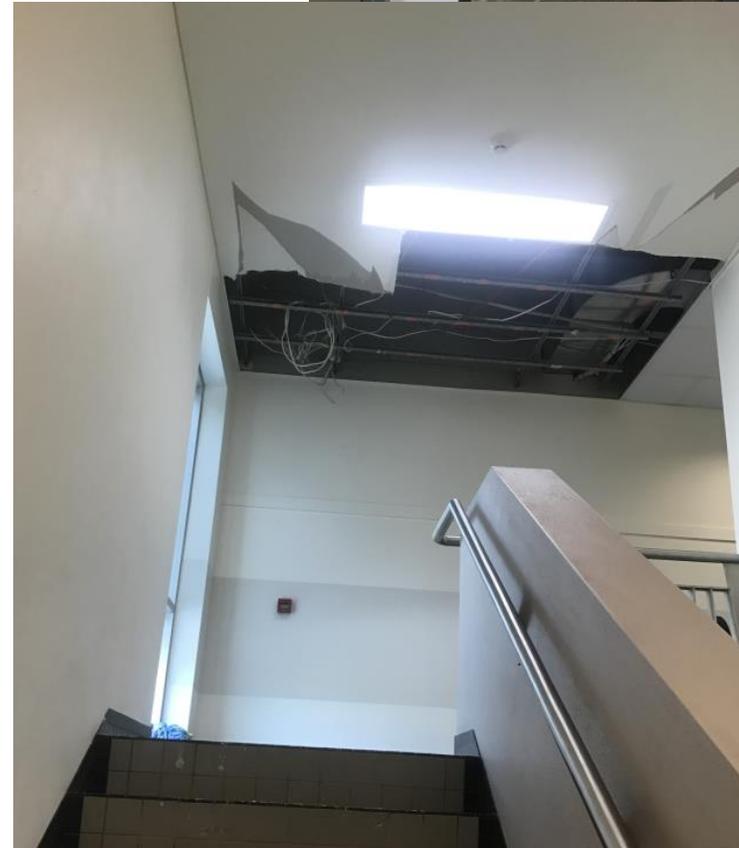
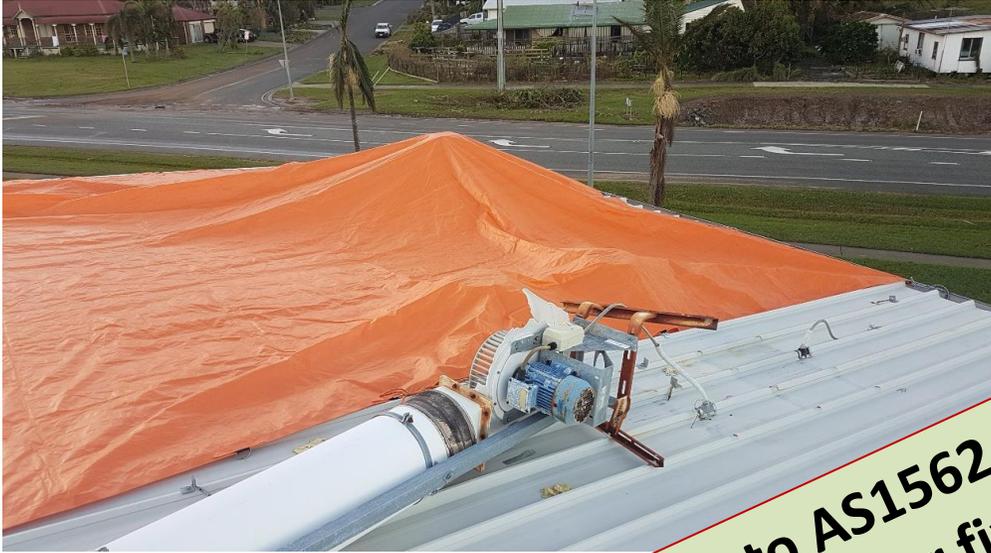
From insurance data → Can be \$1000/m for repair (includes interiors)
(but < \$5/m if build it correct the first time)

Revisions to AS1562.1 for minimum requirements for fixings of attachments

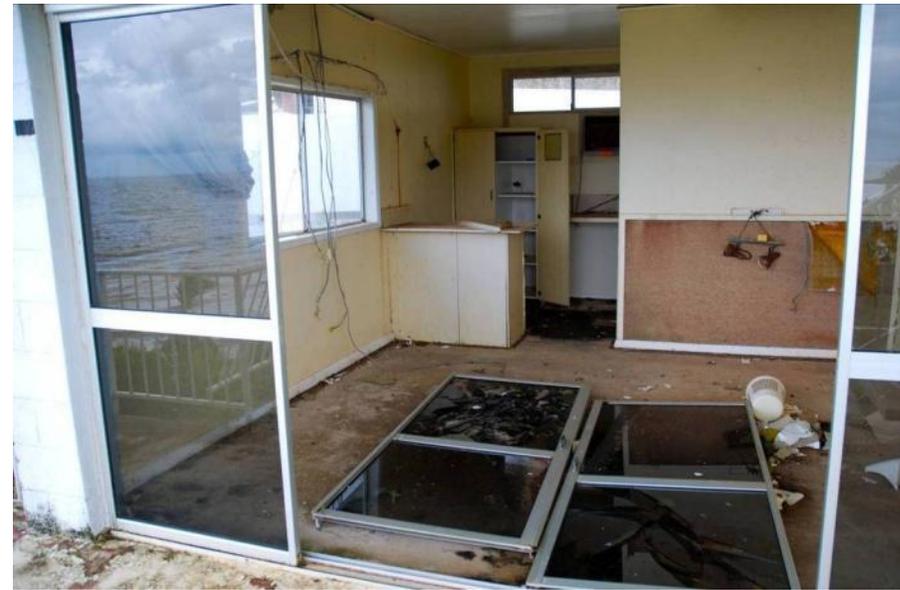
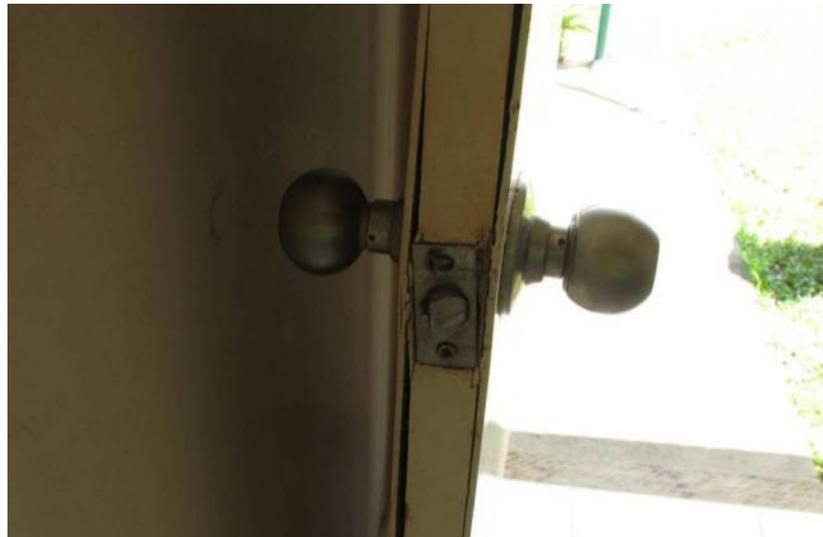
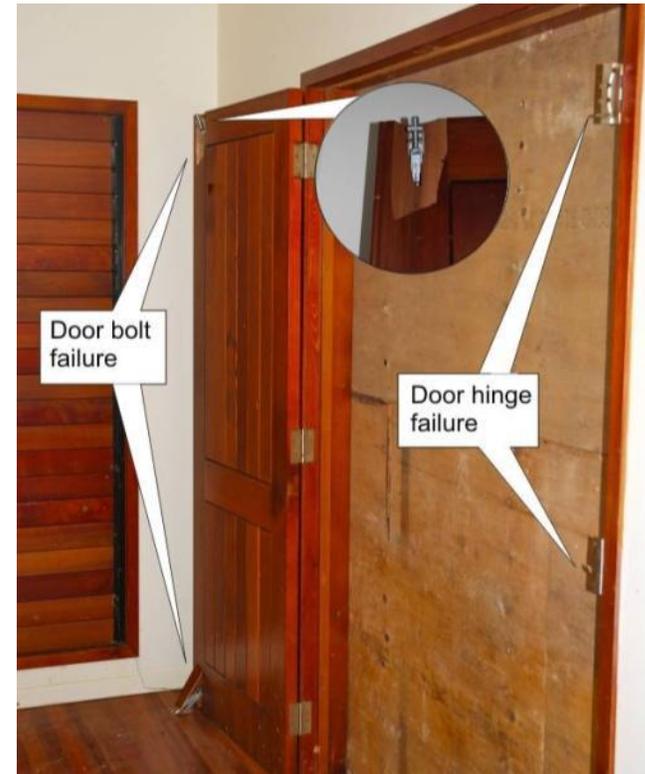
Windows and doors

- Doors and windows are part of the building envelope
- But rare for designers to consider wind loading

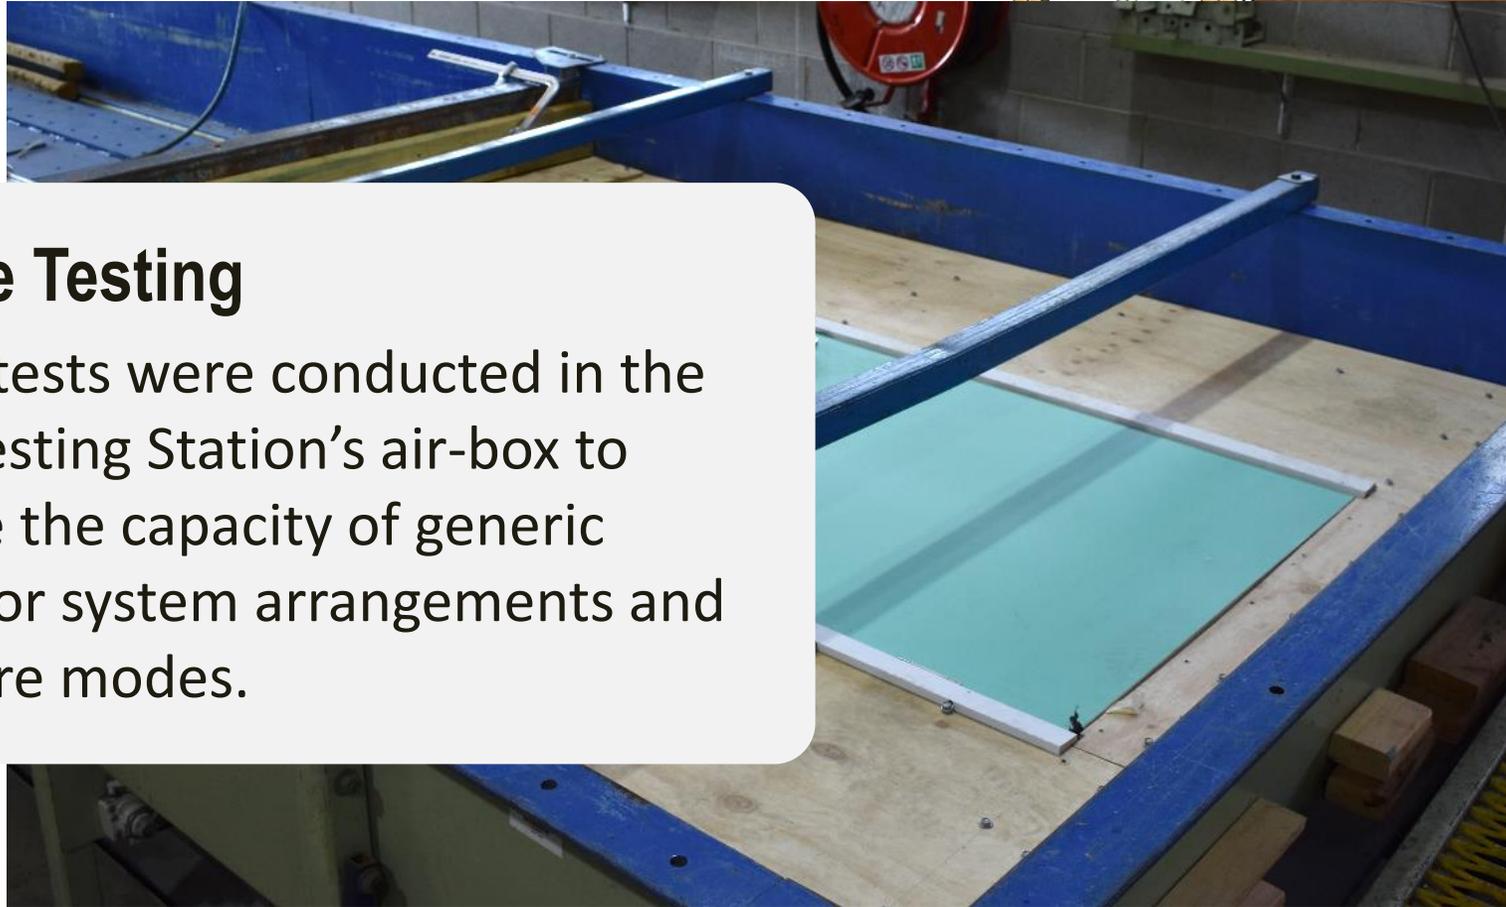
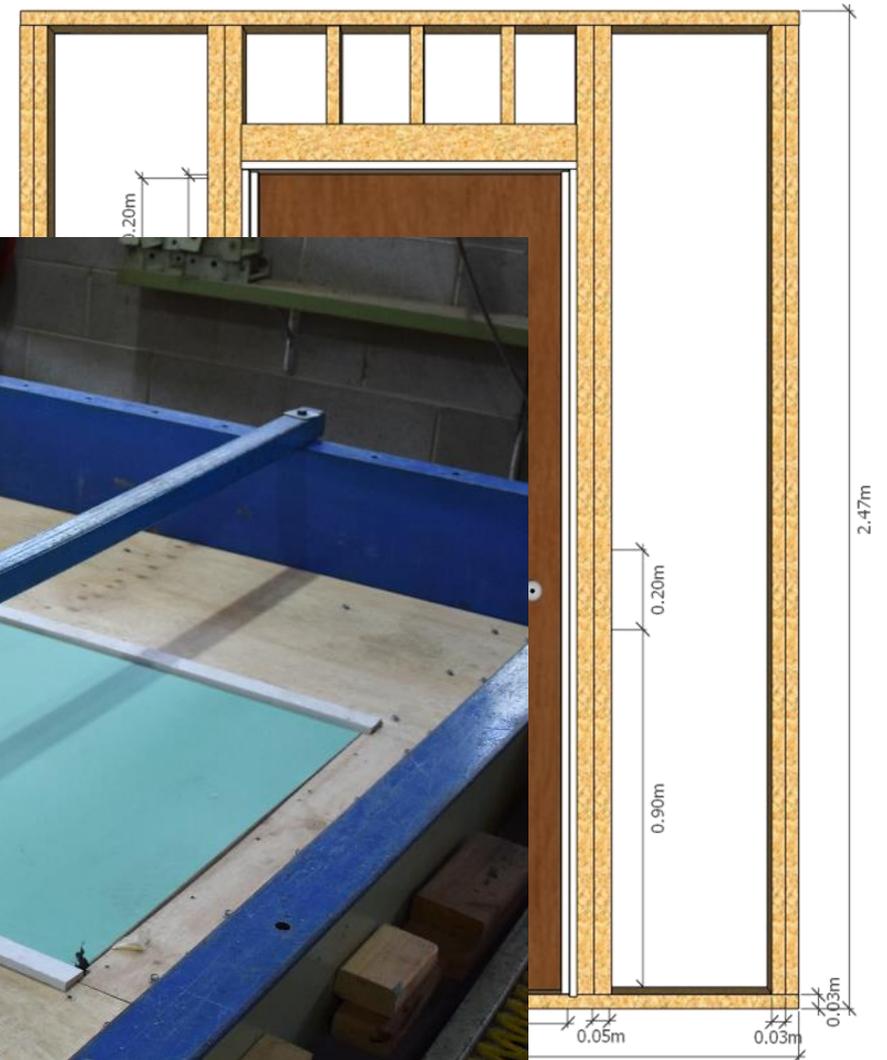
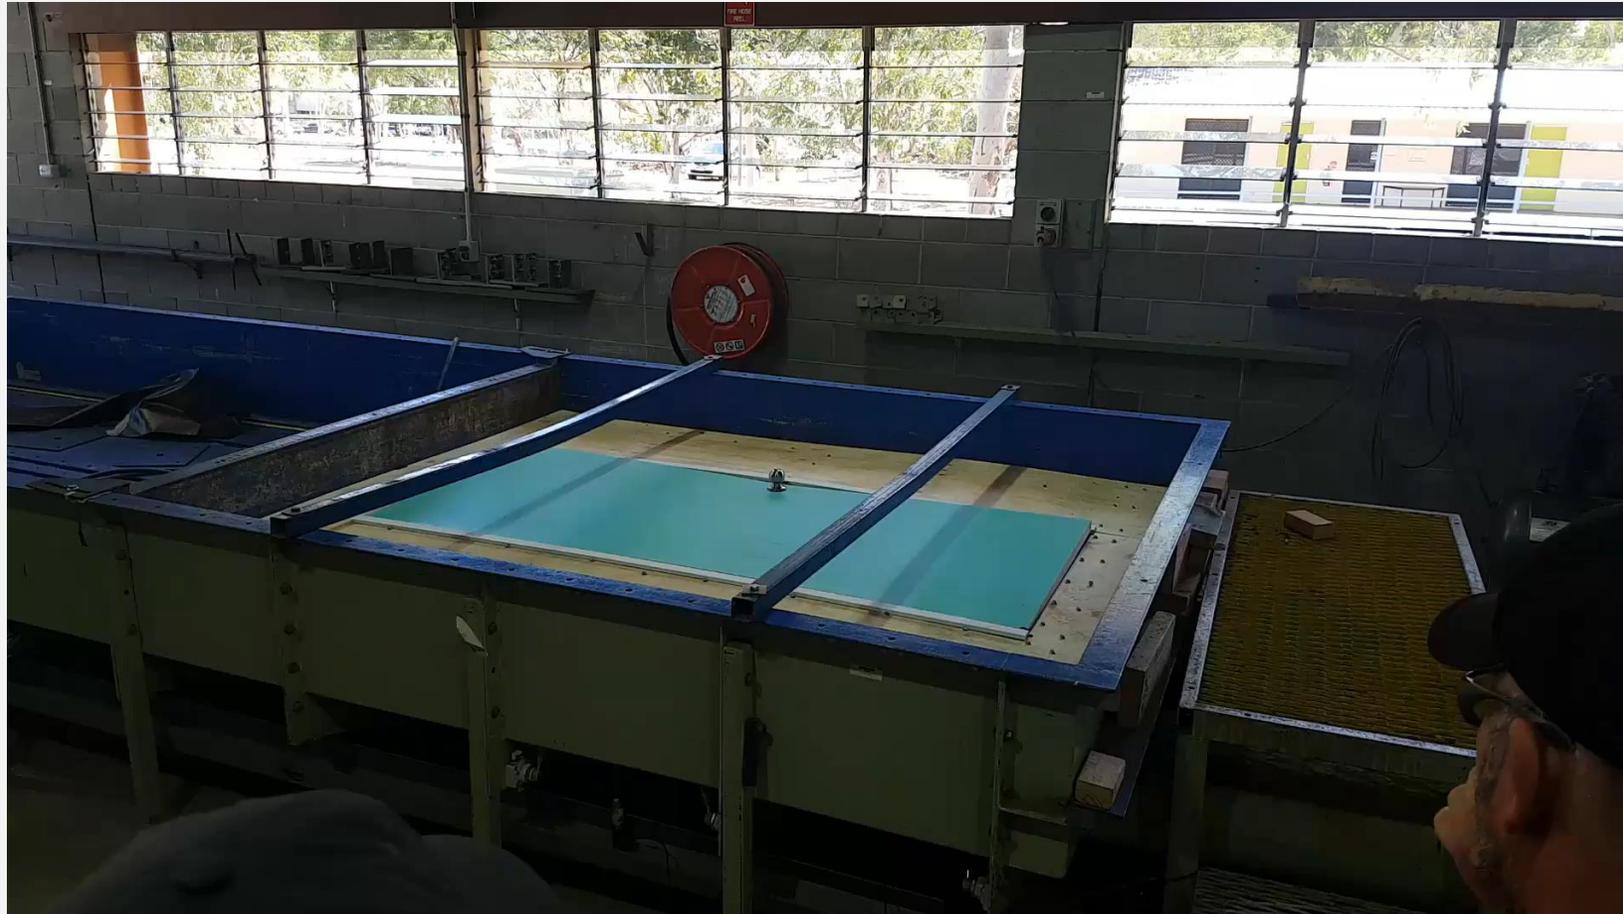
Full-scale Testing

Full-scale tests were conducted in the Cyclone Testing Station's air-box to determine the capacity of generic timber door system arrangements and likely failure modes.
