Large Damage Bills (to buildings) From Cyclones Can Be Reduced By Small Actions

Tropical Cyclone Debbie

Damage to buildings in the Whitsunday Region

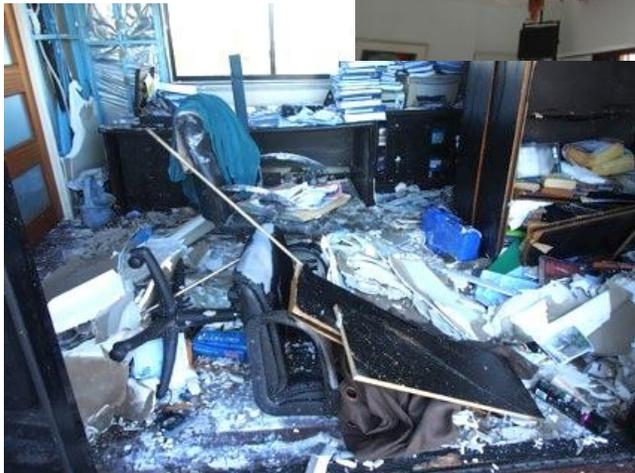
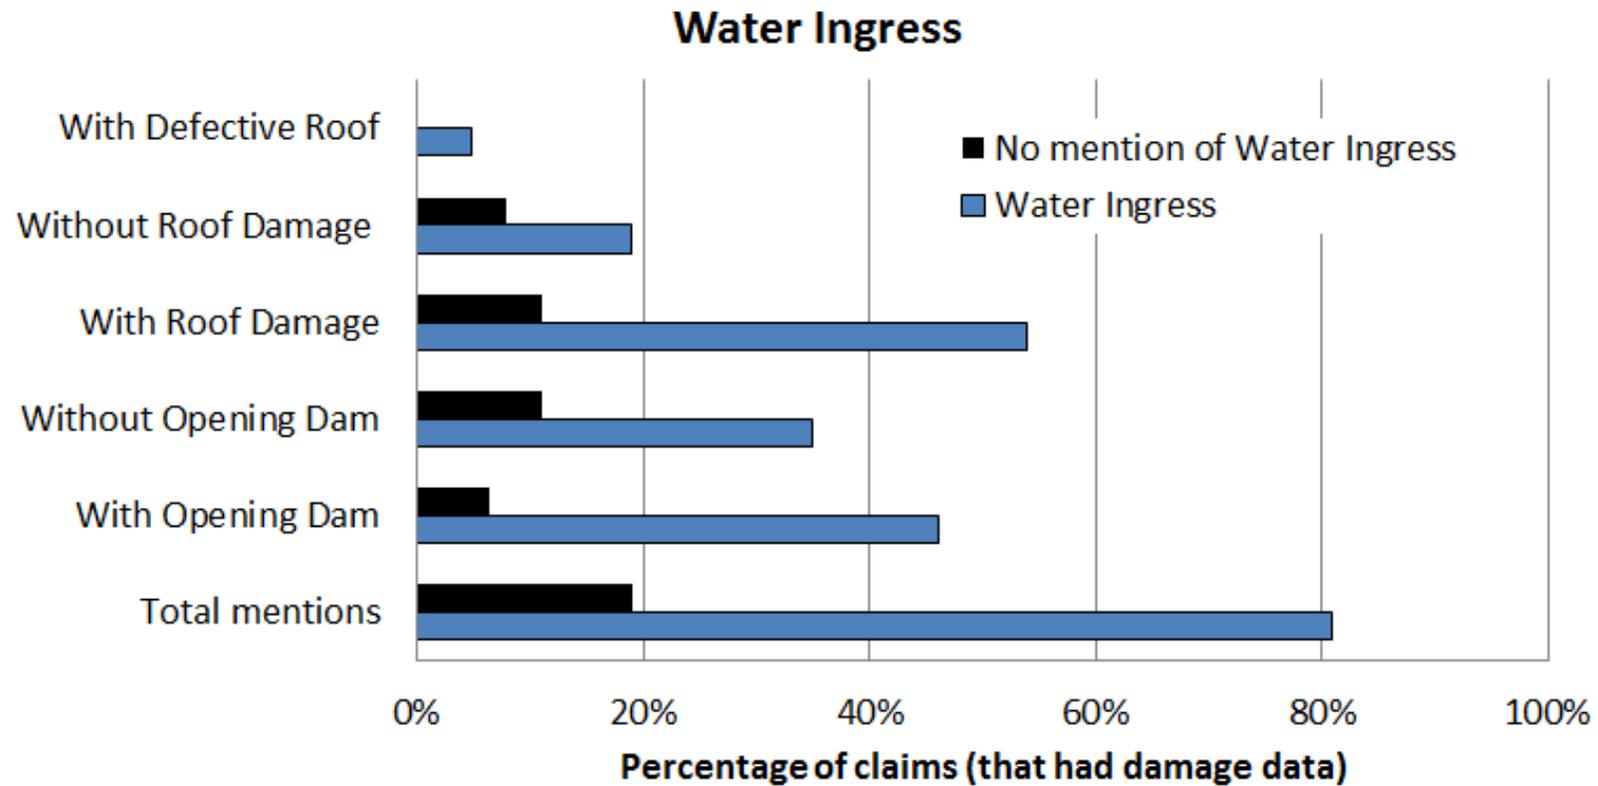
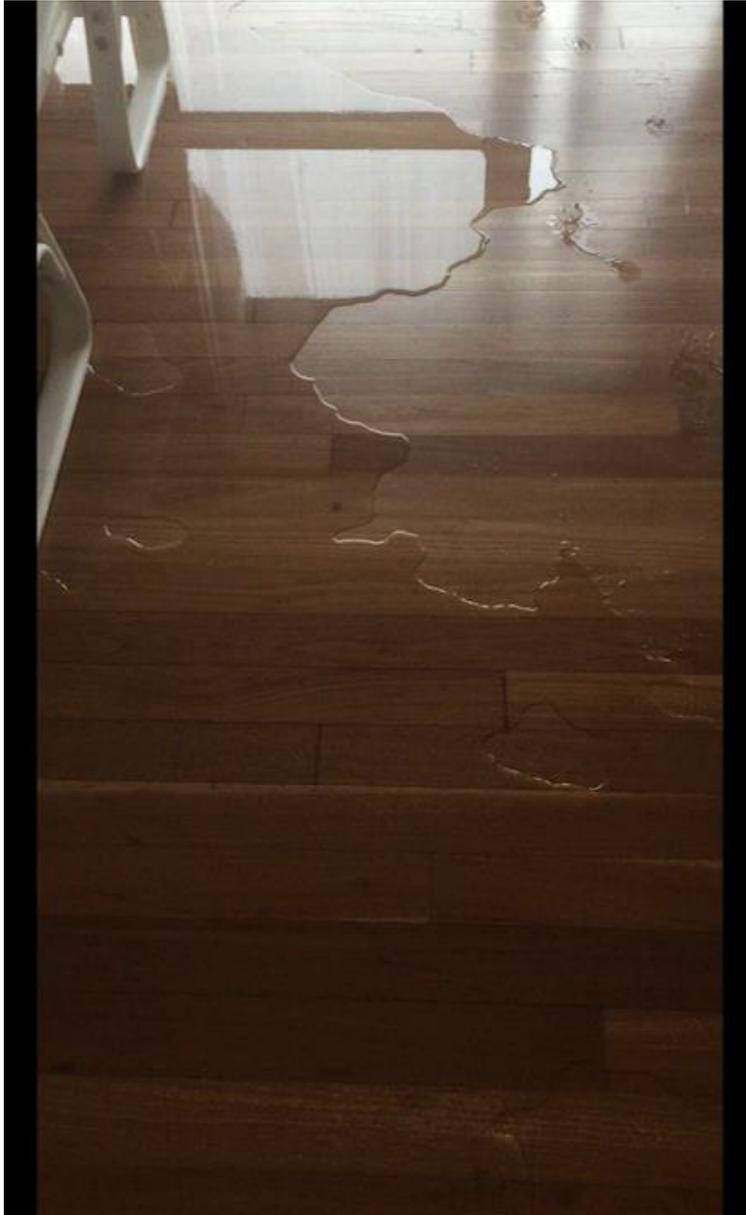
WDR Water ingress

But don't need a
hole in roof to let
the water in

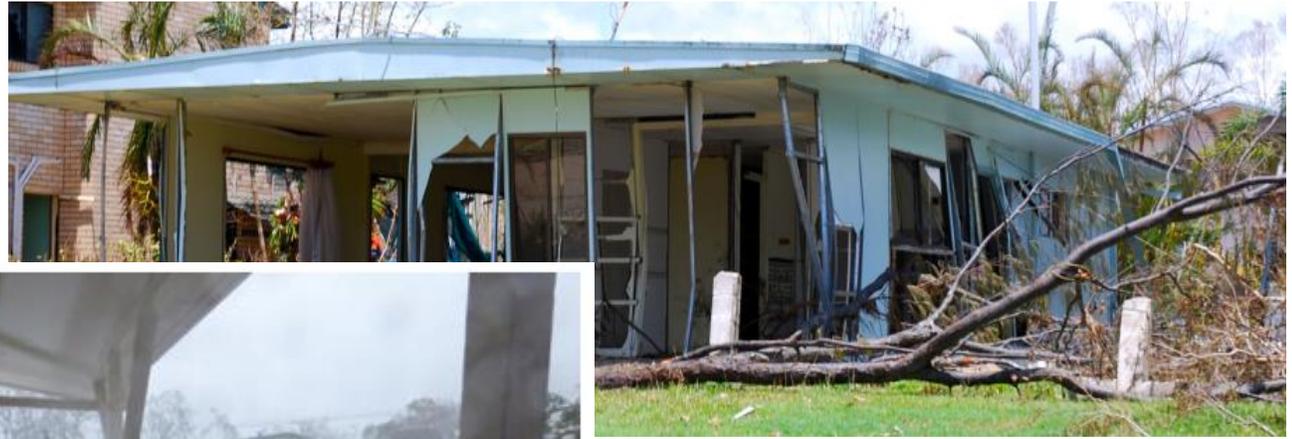
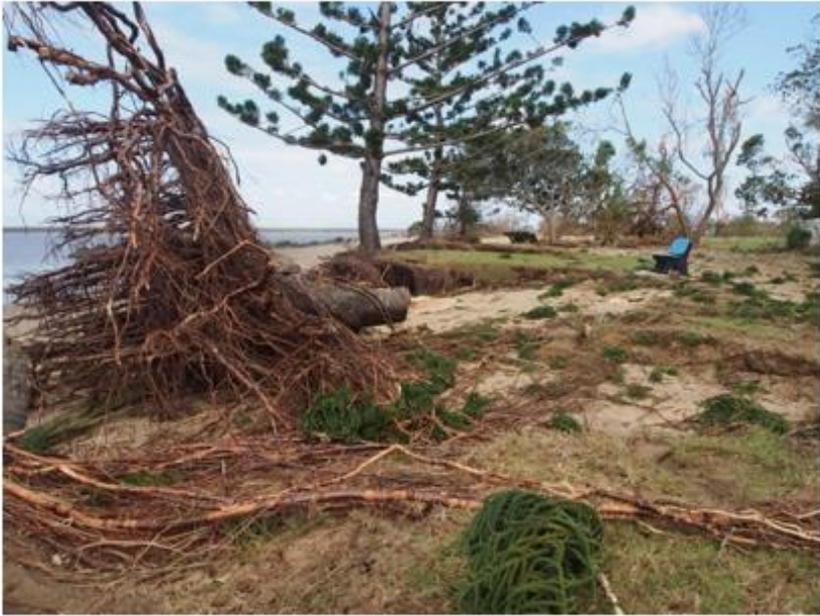
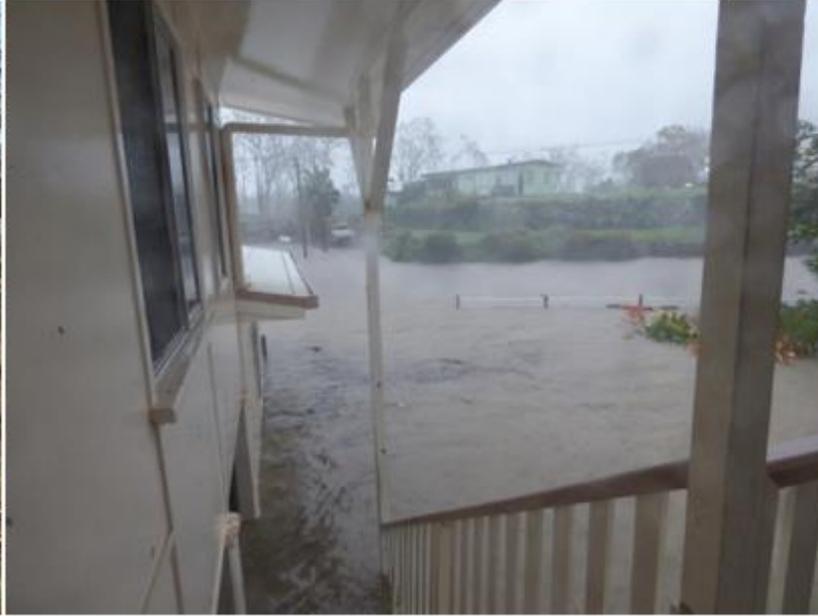
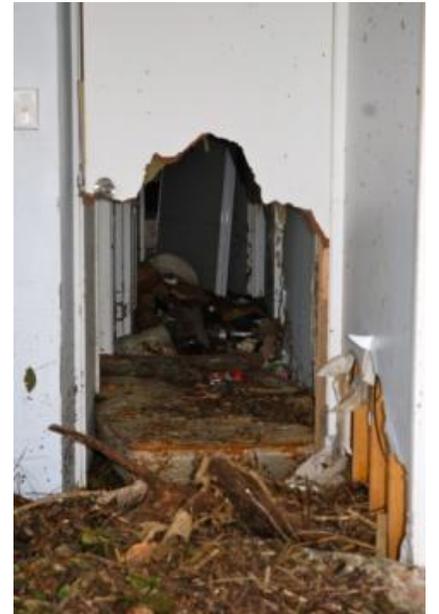
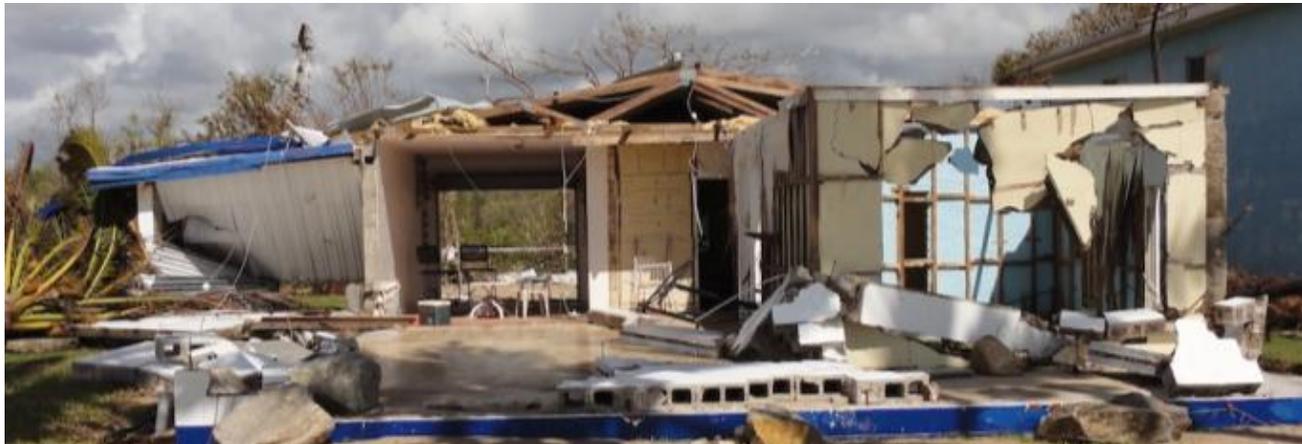
Storm tide damage from TC Debbie and TC Yasi
